PGA RAMP BRIDGE REPLACEMENT PROJECT
FINANCIAL PROJECT NUMBER: 422349-1-52-01
EXTINGUISH THE TORCH SUMMARY REPORT
SESSION III

CEI: Creative Engineering Group Inc.
Turnpike CPM: Ken Hudson
Design Project Manager: Mike Van Der Heyden, P.E. Atkins
EOR: Gary J. Williams, P.E. Wantman Group Inc.

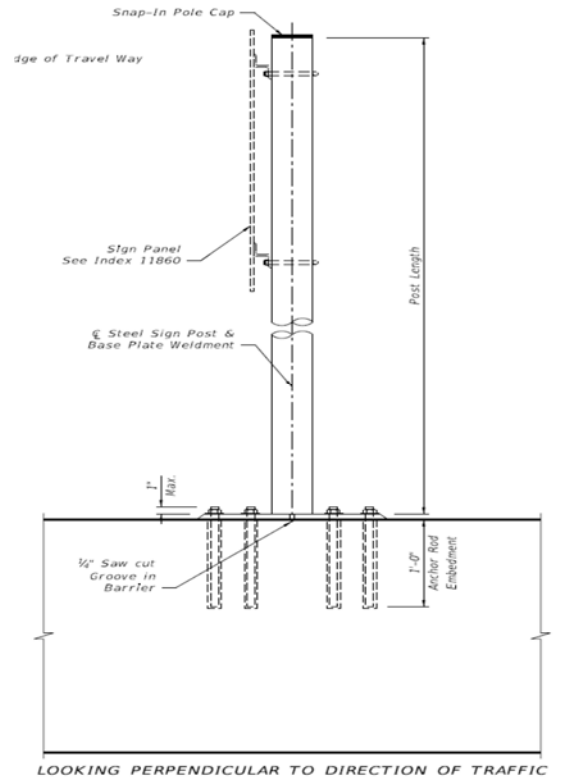
Figure 2 – Revised Single Post Median Barrier Mounted Sign Support

DCE Memorandum 21-12 required the contractor to install all temporary work zone signs on median traffic railings per Design Standard Index 11871. This was a new design standard that addressed installing permanent and temporary sign supports on both permanent and temporary barriers and traffic railings. Prior to this memo, temporary signs were allowed to straddle the wall. They were not included in this standard. This application included a much more labor and material intensive application including adhesive bonding material and 13” anchor rods. The DCE Memo also noted that the payment for the sign will be made under the existing work zone sign pay item. These additional costs to the contractor could not have been known at the time of bid.

A work order was needed to compensate the contractor to install all temporary work zone signs in the various phases throughout the project on the existing median barrier wall per the new Design Standard.

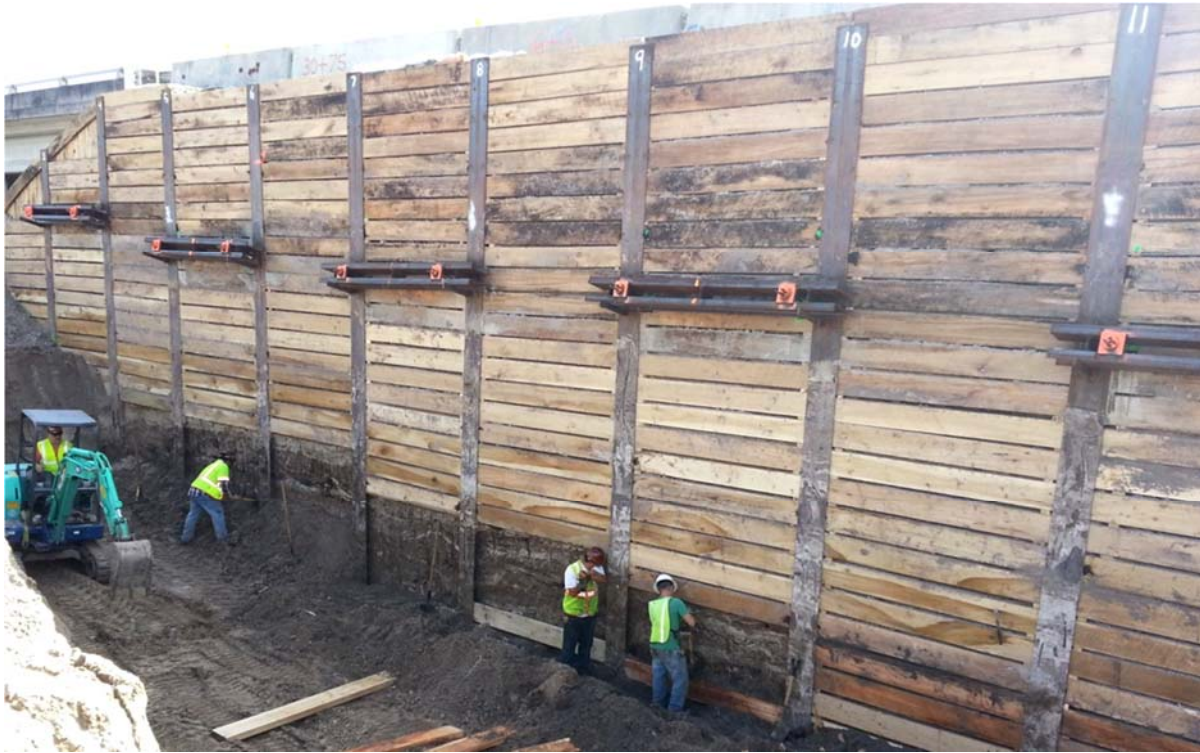
Figure 3 – TW-1 Lag Wall with Soldier Pile Construction in Lieu of Permanent Sheet Pile

Due to the high cost of steel and the inability to remove/recover the driven sheet pile following its use as well as vibration issues during sheet pile driving, the contractor submitted shop drawings for a Temporary Lag Wall with Soldier Piles for Temporary walls TW#1 and TW#3, in lieu of Sheet Piles. These shop drawings were approved by the Department and a CSI was approved. This resulted in a cost savings of \$ 34,620.00 to the department.

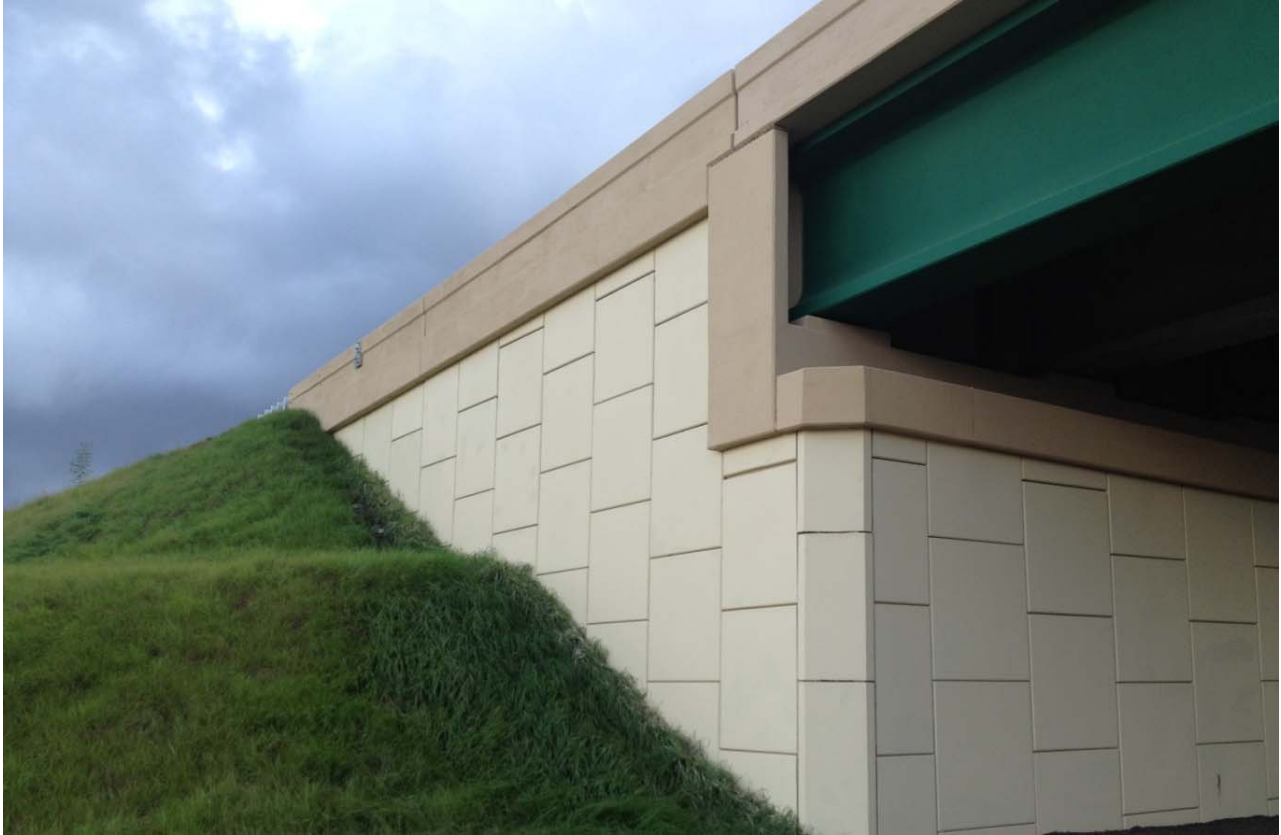
Figure 4 – Class V Color Change

The contractor was required to apply a class 5 finish on the structure items listed on plan sheet B-03, note “T” Applied Finish Coating. The color scheme for the required class 5 finish was not listed in the plans. Florida’s Turnpike Enterprise (FTE) requested a change to follow a multicolor scheme of the class 5 finish to enhance the aesthetics of the new structures as well as to bring consistency to all newly constructed FTE facilities. The requested colors were as follows:

A work order was needed to compensate the contractor for the extra costs involved in applying a multicolor class 5 Applied Finish Coating on individual structure items in lieu of applying a single color class 5 finish on all the structure items.

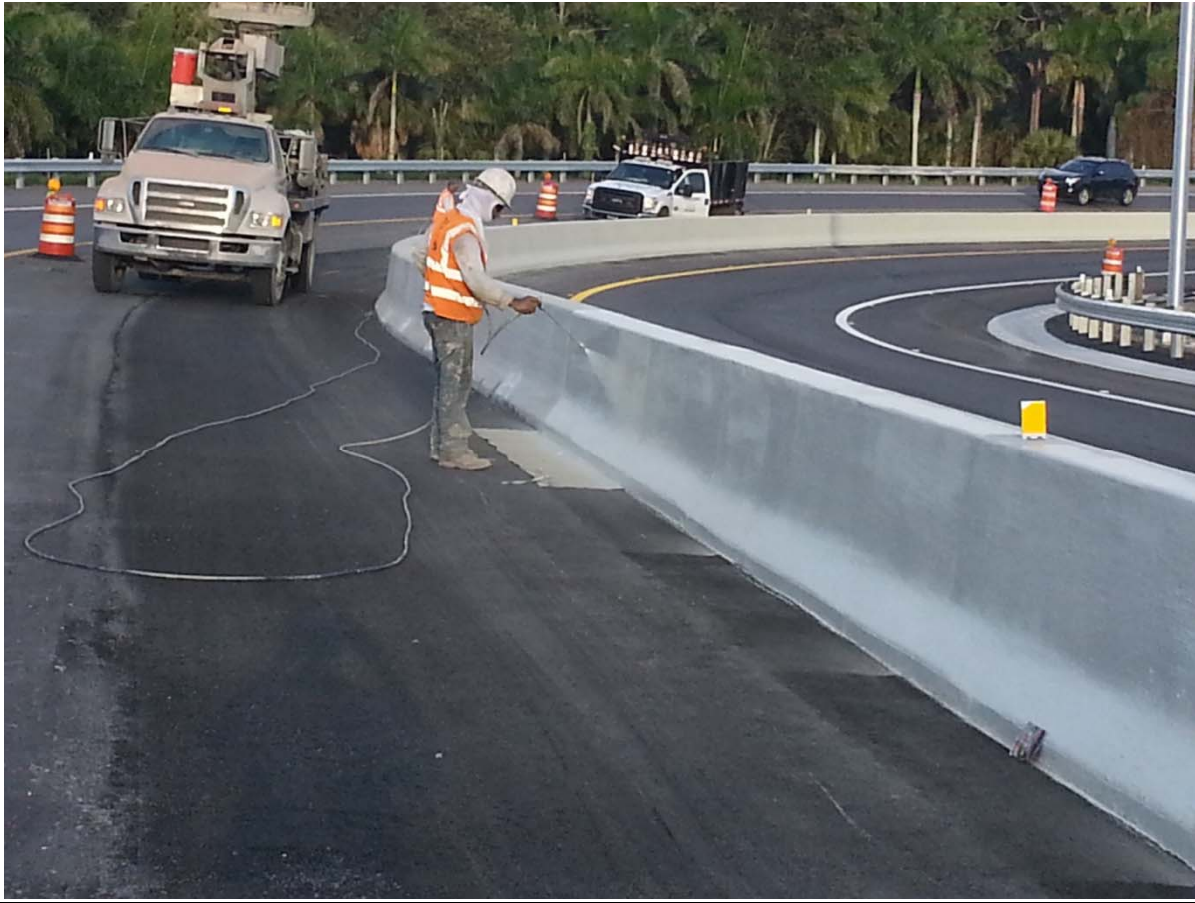
Figure 5 – Application of Additional Class V Finish

The design plans did not include the application of a class V finish on the newly constructed median concrete barrier wall surfaces along the new ramps. The EOR listed all concrete items which required a class V finish application including bridge traffic railing, exterior beam faces, edge of deck and underside of cantilever, edge of end bents, caps and pier, and MSE walls on plan sheet B-03. This list did not include the median traffic railing along Ramp AB.

Also, the nearby recently completed Indiantown Road Interchange Project had a class 5 finish coating on the median concrete barrier walls. A work order was needed to compensate the contractor for the extra costs associated with applying the additional Class V Finish Coating along the ramp median barrier walls to enhance the aesthetic uniformity through the Florida’s Turnpike Enterprise (FTE) System.

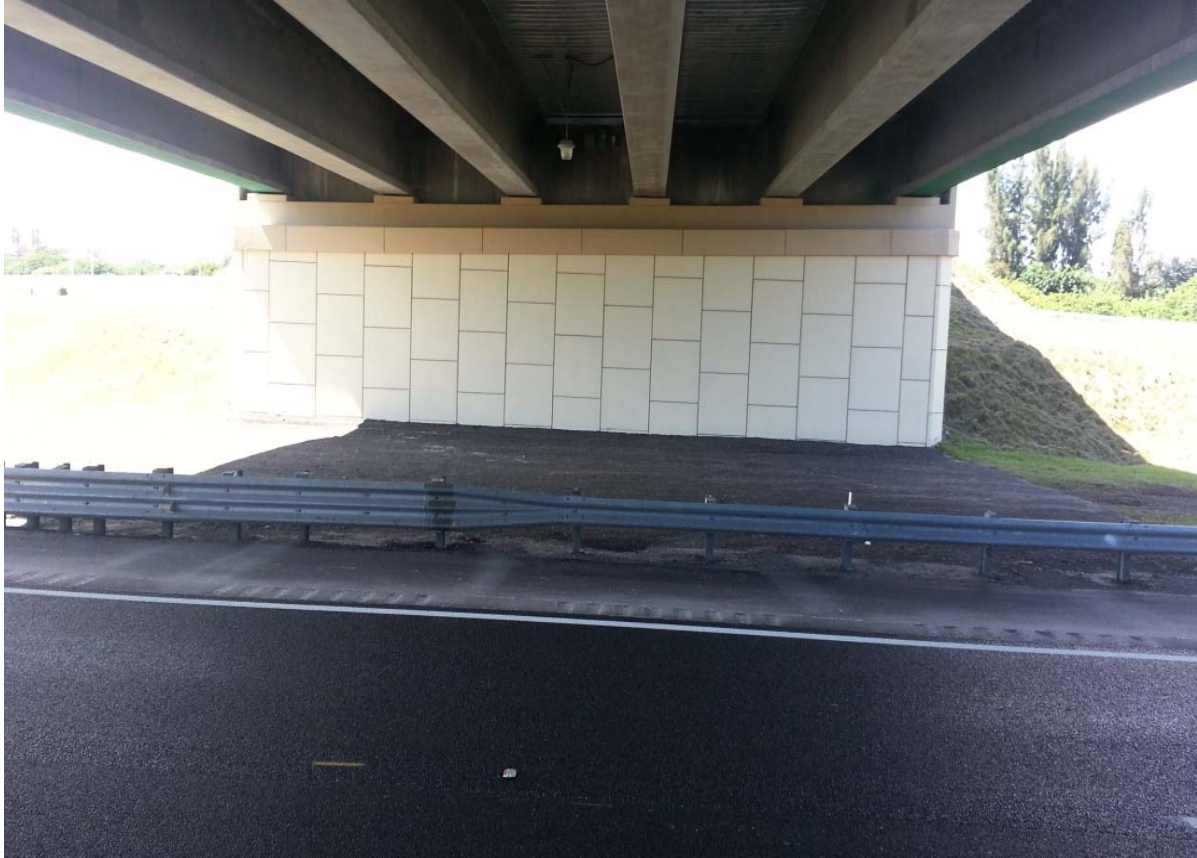
Figure 6 – Millings in Lieu of Performance Turf below Bridge

The plans proposed to place performance turf below the newly constructed bridge in the areas enclosed between the edge of the outside shoulder pavement and the MSE wall on both the East and West sides of the Turnpike. However, these areas will need to be maintained on a regular basis. Since the area is beneath the bridge and will receive minimal water beyond the establishment period the grass would struggle to survive and provide the necessary aesthetic appeal that turnpike users are accustomed to.

A work order was needed to compensate the contractor to furnish, spread, grade, and compact milled asphalt material to avoid any future maintenance issues by stabilizing the areas with a compacted layer of milled materials in lieu of performance turf.

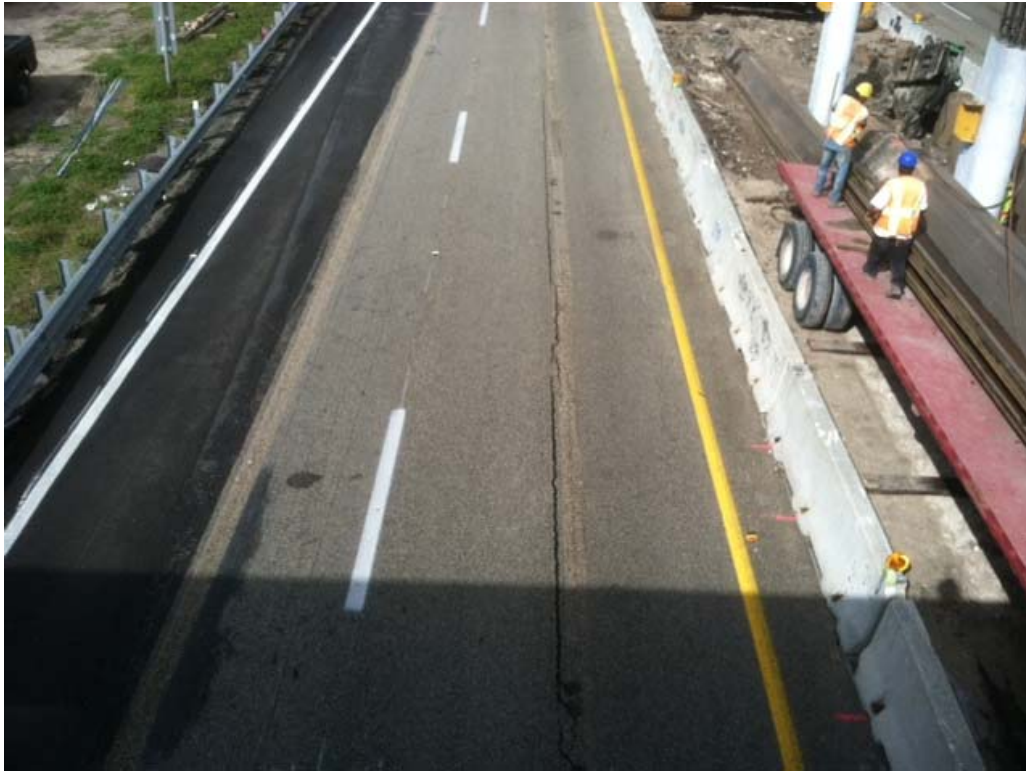
During the driving of temporary critical sheet pile wall TW-3 within the median of mainline Turnpike, it was observed that cracks were beginning to appear longitudinally along lanes of the Turnpike Mainline, in both northbound and southbound directions. Following the extraction of the sheet pile wall which resulted in further settlement and further review of the condition with FTE Engineers, it was concluded that these cracks occurred due to reasons beyond the control of the contractor and were a result of the existing subsurface condition while providing the contract work.

Subsequent monitoring of the crack and base investigations revealed that the base was in good condition and the crack and subsequent pavement settlement occurred as a result of typical vibration during the driving and extraction of the required sheet pile wall. Once identified the cracks were temporarily sealed with RPM adhesive to prevent further water intrusion. The permanent repair involved a deep milling during the scheduled mainline milling and resurfacing operations to remove the entire thickness of asphalt and to correct the cross slope. A Supplemental Agreement was written to compensate the contractor for the work to repair the mainline cracks and settled pavements between Station 3260+46 and 3261+62 on lane R1, R2, R3, L1 and L2.

Figure 7– Southbound Mainline cracking Lane L-1 (shifted) adjacent to Median Pier 2

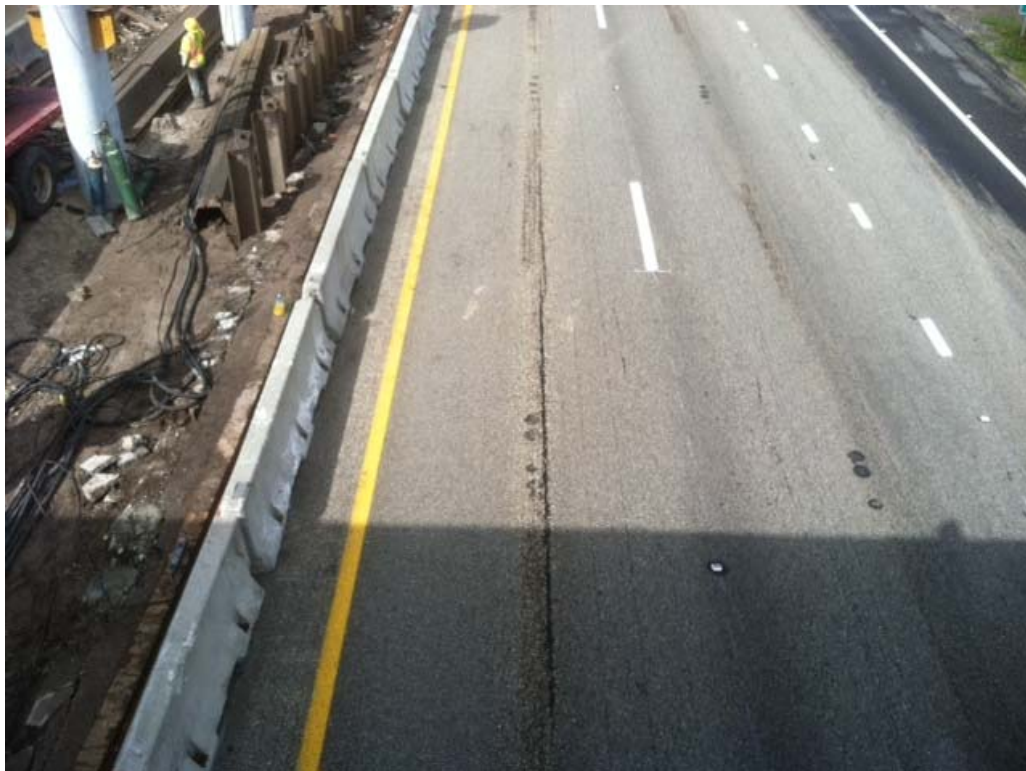
Figure 8 – Northbound Mainline cracking Lane R-1 (shifted) adjacent to Median Pier 2

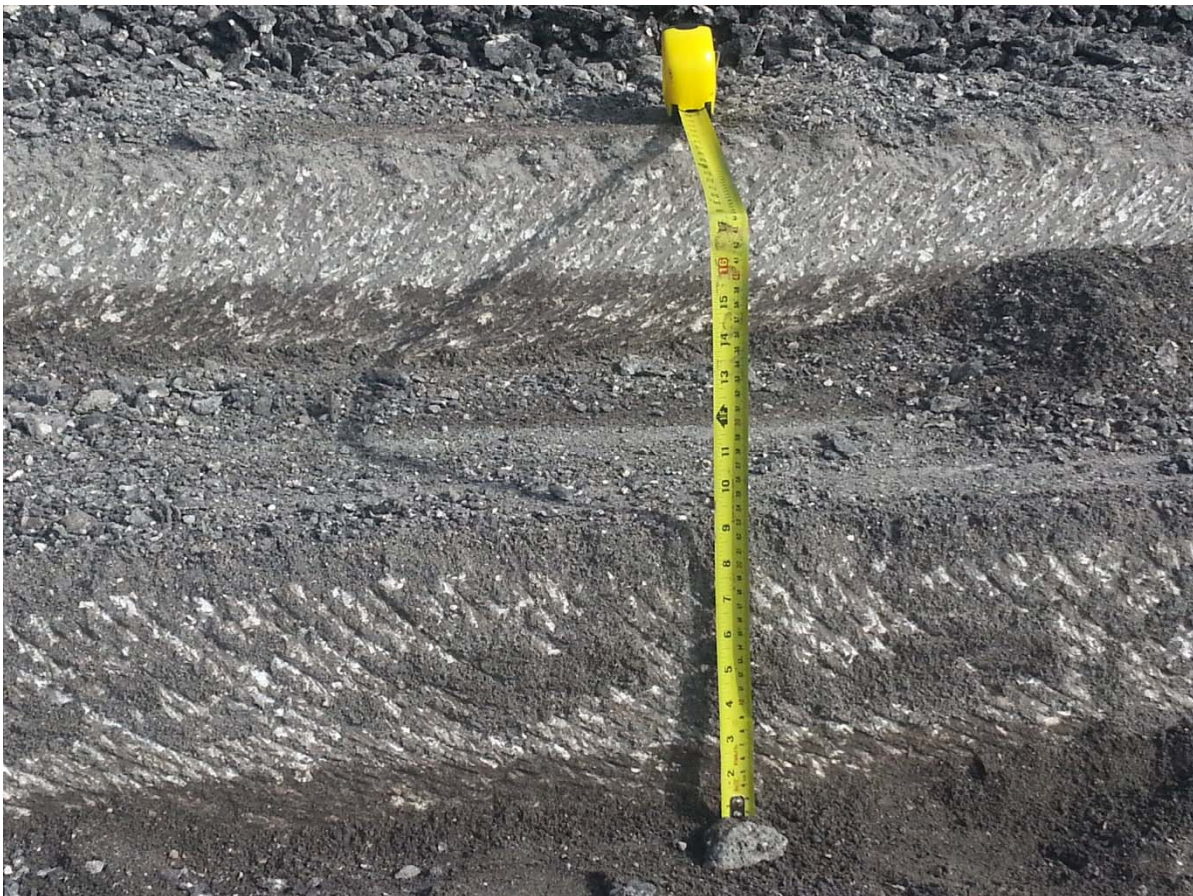
During the Clearing and Grubbing operations, the contractor encountered an excessive thickness of existing asphalt on the approaches to the existing bridge between stations 105+40 and 123+02 (+/-). The thickness of the extra depth asphalt varied between 12” and 20”. It was later understood that this extra depth was due to a previous bridge-jacking operation

of the PGA ramp bridge which raised the elevation of the bridge to provide additional clearance above the Turnpike. The existing approaches had been raised to a new elevation utilizing layers of asphalt pavement in order to achieve the final Profile Grade Line which was currently in place. This excessive thickness of asphalt was not denoted in the plans and could not have been expected.

Figure 9 – Excessive Asphalt Thickness at Bridge Approaches

A Supplemental Agreement was needed to compensate the contractor for the mobilization and daily rental rates for the milling machine in separate construction phases to provide the necessary resources to convert the excessive in-place thickness of asphalt into usable embankment material as much as possible.

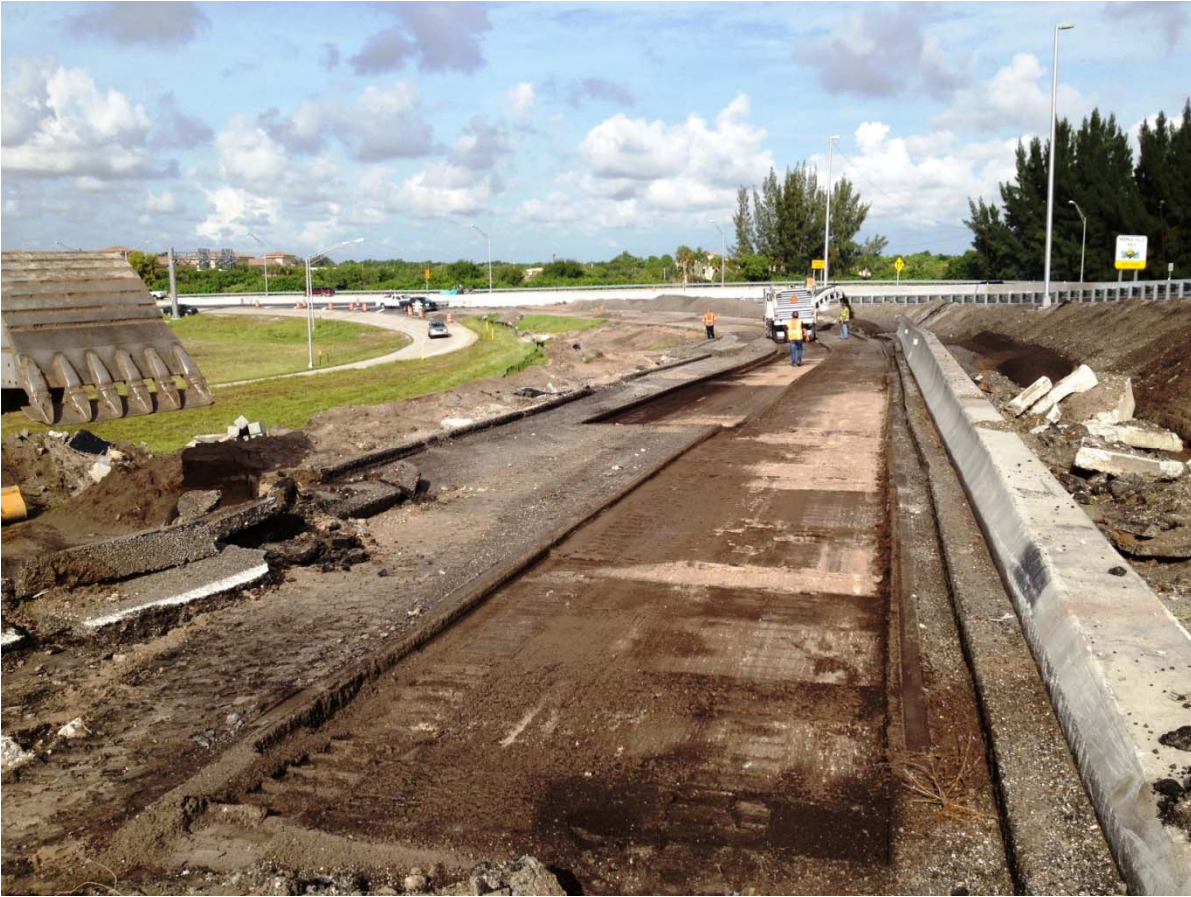
Figure 10 – Utilization of Excessive Asphalt Thickness at Bridge Approaches

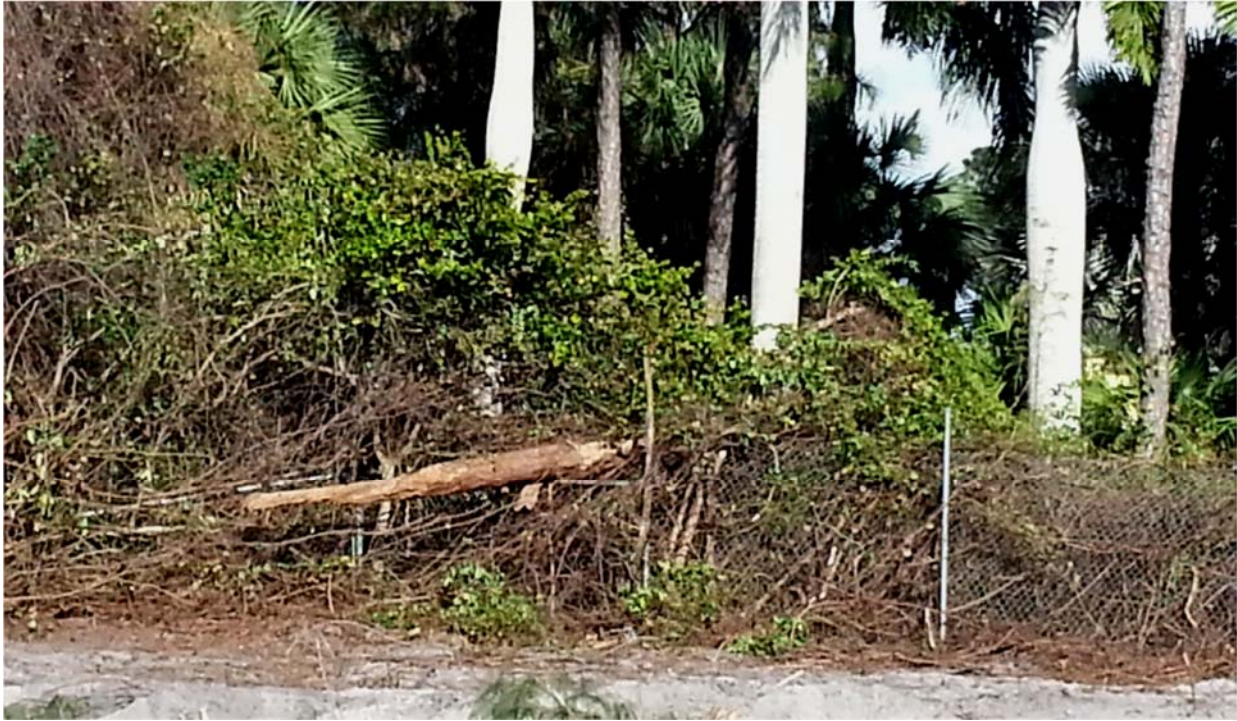
Figure 11 – Condition of Existing Fence

The clearing and grubbing limits shown in the plans extended to the Turnpike's ROW for the construction of the new North bound off-ramp. During the removal of the extremely heavy vegetative growth approaching the ROW fence line, it was noticed that the existing fence was completely destroyed and would no longer secure the right of way as needed for a Limited Access Facilities nor would it provide the necessary aesthetic appeal that turnpike users are accustomed to.

The condition of the fence could not have been determined by the designer and/or the contractor prior to the removal of the vegetation.

With the assistance and support of FTE's Maintenance Division, Mr. Hossein Barekat quickly approved the mobilization of a fence contractor through a maintenance contract to remove and replace the fence. This allowed the contract work to continue without the need to shut down the clearing and grubbing operations as well as eliminated the need to negotiate a cost through the construction contract which would in all probability be higher than the contracted rates through the maintenance contract.

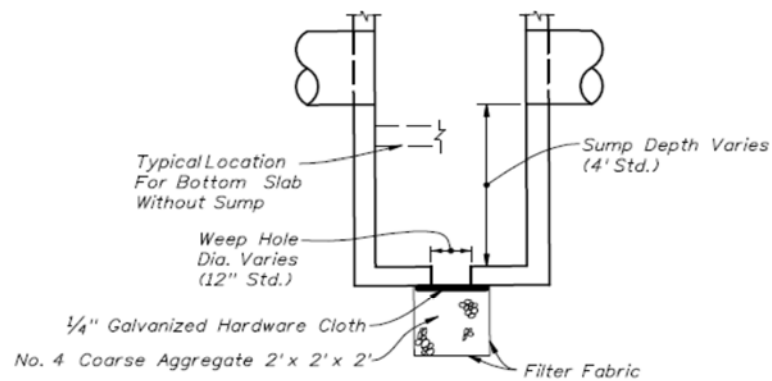
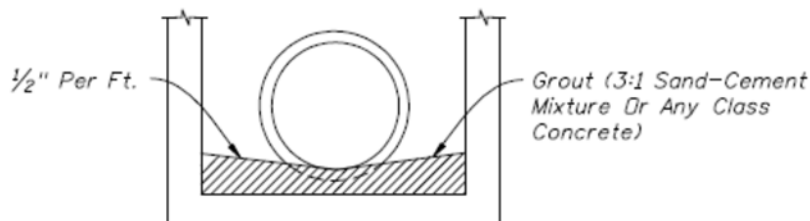
Figure 12 – Standard Index 201 (sheet 2 of 5)

Standard Index 201 (sheet 2 of 5) includes a note which states that sump bottoms are to be constructed only where called for in the plans. A poured bottom is required for all other drainage structure inverts.

All drainage structures are manufactured with a small 8"-12" sump in them. Many agencies (including permitting agencies) will direct you to not construct the poured invert bottom because it has several drawbacks including the visibility of the silt and trash passing through the outfall pipe which becomes much more visible to the public. If the poured invert has already been constructed, some agencies will insist on the removal of the invert.

A poured invert bottom may eliminate the maintenance of each individual structure but it adds a large amount of maintenance and visibility to the collecting basin/pond including trash removal and silt build-up which reduces storage capacity.

Lesson Learned- The designer should investigate the individual agency requirements for poured invert bottoms within drainage structure and include a note in the plans if/when required.
