## **EXTINGUISH THE TORCH MEETING SESSION ONE**

Project: Resurfacing & Safety Upgrades of Turnpike Mainline (SR 91)

## Summary Report

### Resurfacing & Safety Upgrades of (SR 91)

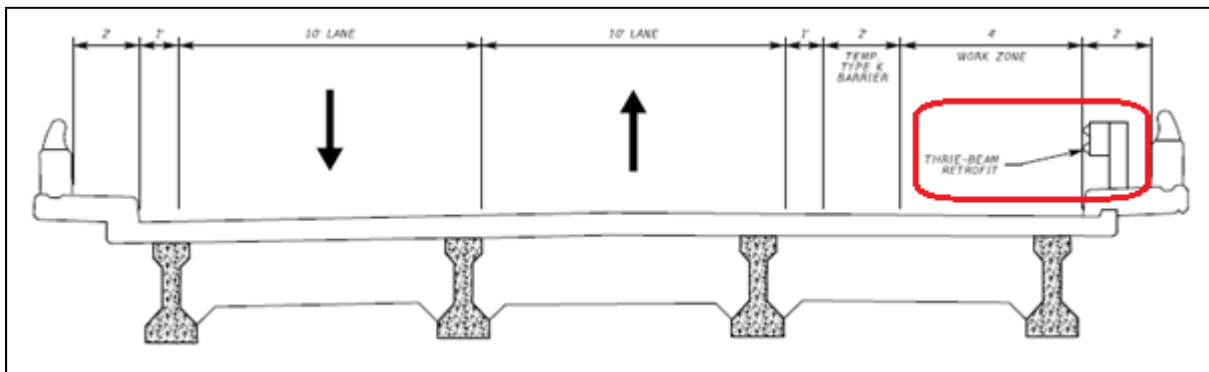
### 1) Metal Traffic Railing (Thrie Beam Retrofit) – Missing pay items & MOT

Plan details and pay items were not included in the contract, for planned thrie-beam upgrades to bridges crossing over the Turnpike. Several challenges would result if this work had been pursued, as several work components were not included in the contract (such as traffic coordination with Osceola County, and additional costs not in the original contract).

Quantities not included in the contract for the thrie-beam installation: Barrier Wall Temporary, F&I, Type K, Temporary Crash Cushion, Redirective Option (8 installations), MOT associated with thrie-beam operation, striping plan, advance warning, and thrie Beam transition from bridges. The estimated cost for these omitted items was approximately \$150,000.

Also, note that a 4' work area restricts the Contractor's equipment access.

The thrie-beam retrofit work was deleted from this project. A future widening project is planned at these four bridge locations.

Recommend an evaluation of bridge sites during design, to fully understand & define the MOT needs.

EOR to provide details on connection of thrie-beam to existing guardrail.

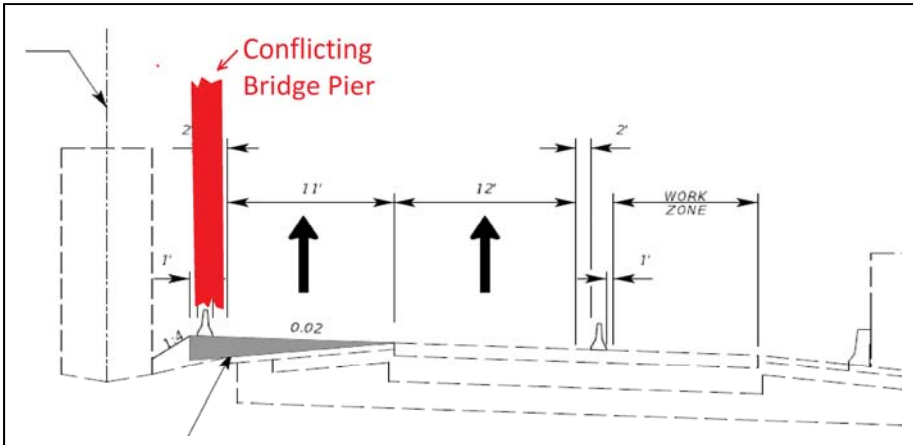
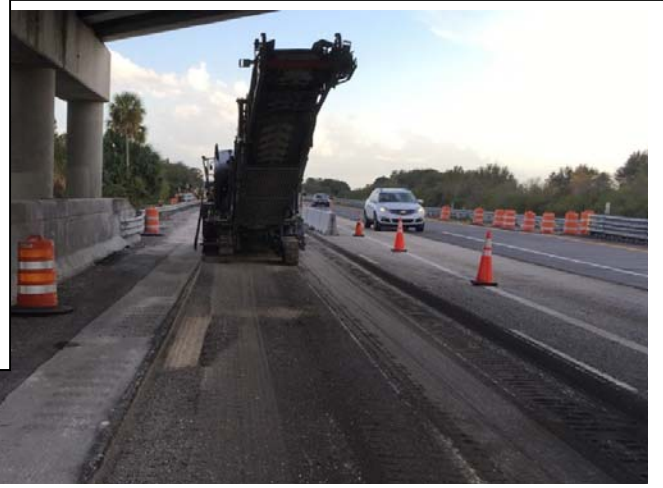
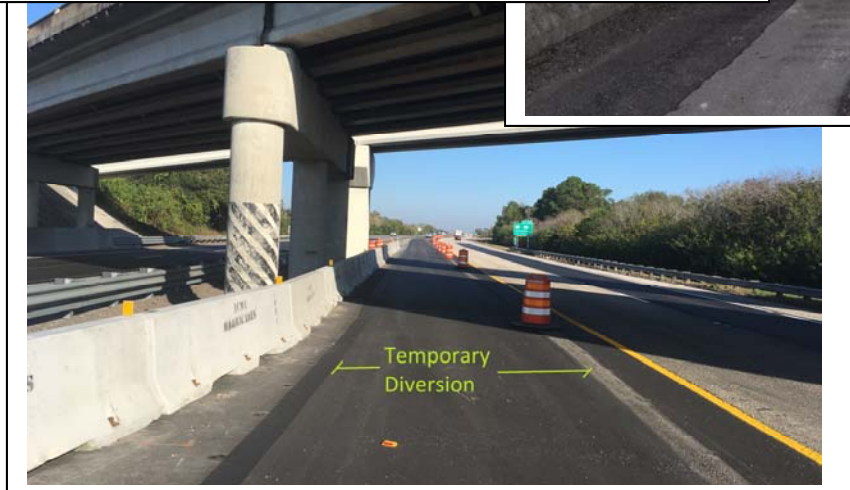
## 2) Conflict between bridge pier & temp. barrier wall during diversion

The Neptune Road bridge pier was located within the limits of a temporary diversion, and would not allow the required 11' & 12" lane widths. This temporary diversion was needed to deep mill the northbound lanes to repair full depth cracking.

Shortened the traffic diversion length to avoid the bridge pier. The remaining diversion length was paved with a continuous milling & paving operation (Sunday afternoon through Monday morning), without the use of a barrier wall.

Design team to account for any conflicts when designing traffic diversions. In this case, the presence of a bridge pier had not been taken into account.

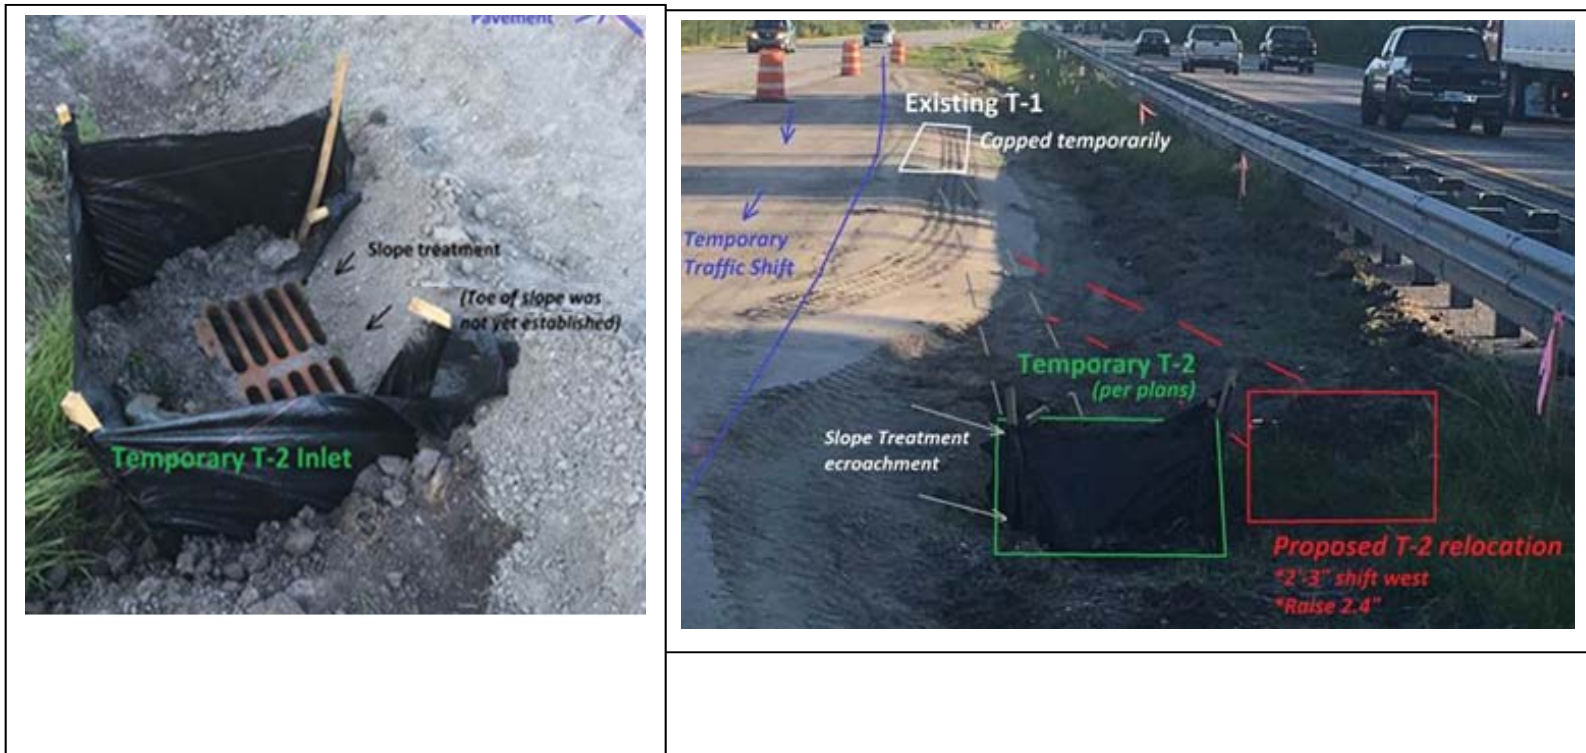
## 3) Conflicting drainage structure with traffic diversion

A temporary drainage structure conflicted with the temporary diversion's toe of slope. After the structure's installation, it was discovered that the slope between edge of temporary pavement & structure would need to be steeper than 1:4 to avoid the temporary inlet.

EOR provided a revised location & elevation for the structure, and a re-installation was performed by work order. This adjustment to the drainage structure allowed the front slope to be a minimum of 1:4.

Have the plans show cross sections for the temporary drainage structures, in conjunction with temporary diversions. This likely would have identified the conflict prior to construction.

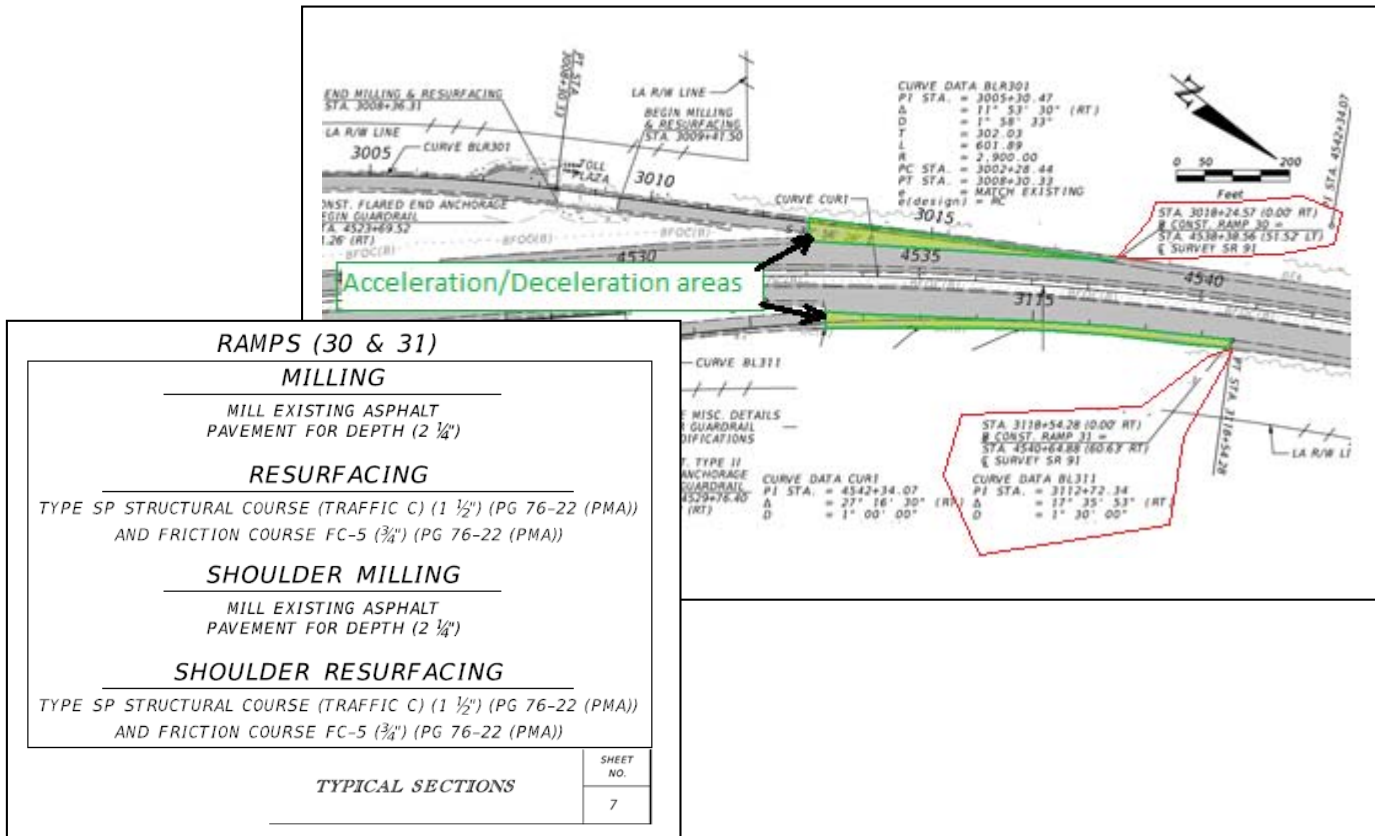
4) Ramps typical sections didn't show begin/end stations for milling & resurfacing

Typical sections do not show stations, which leads to confusion about resurfacing scope for ramp accel/decel lanes.

Clarification was obtained to establish the ramp limits. This involved coordination with the EOR, Bituminous Engineer and Contractor.

Depict ramp limits starting & stopping at the gore area.

This could be done by including limits on typical sections or a legend on plan sheets.

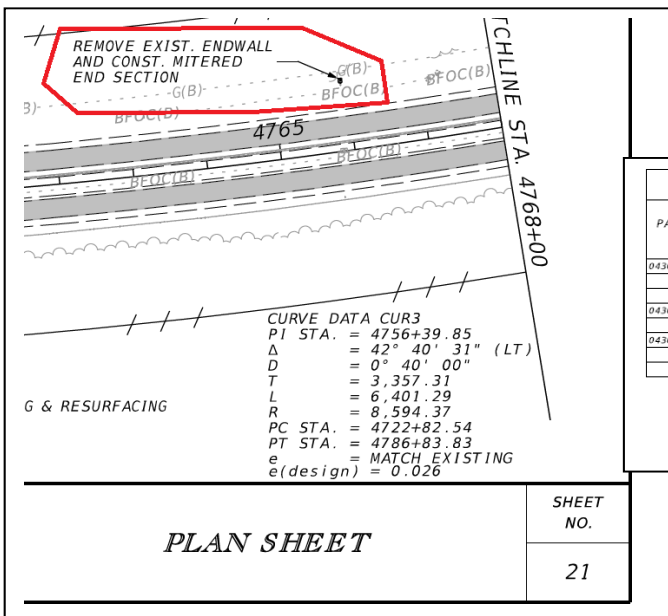
SUMMARY OF QUANTITIES		SHEET NO.
		50-12

6) Headwall removal not included in summary of quantities

Plans removed an existing endwall & constructed a mitered end section. However, the summary of quantities didn't include pay items for the work. Only one other MES replacement was in the contract pay items, but was not the size needed. The note for this work was not seen until after all other drainage work was performed, and the Contractor had to re-mobilize to perform this work.

SUMMARY OF MISCELLANEOUS DRAINAGE ITEMS								
PAY ITEM NO.	PAY ITEM DESCRIPTION	LOCATION		SIDE	UNIT	QUANTITY		TOTAL
		STA.	TO STA.			P	F	P
0430 94 1	DESILTING PIPE, 0-24"	1433+75.00		RT	LF	24.0		142
		1437+50.00		LT/RT		118.0		
0430175124	PIPE CULVERT, OPTIONAL MATERIAL, ROUND, 24" S/CD	1437+50.00		LT	LF	6.0		6
0430982129	MITERED END SECTION, OPTIONAL ROUND, 24" CD	1437+50.00		RT	EA	1.0		1
	<b>Needed 18" MES @ Sta. 4766+00</b>

The Contractor was compensated by work order, to re-mobilize & perform the work. This included premium cost.

Summary of quantity sheets should accurately include all pay items for work.

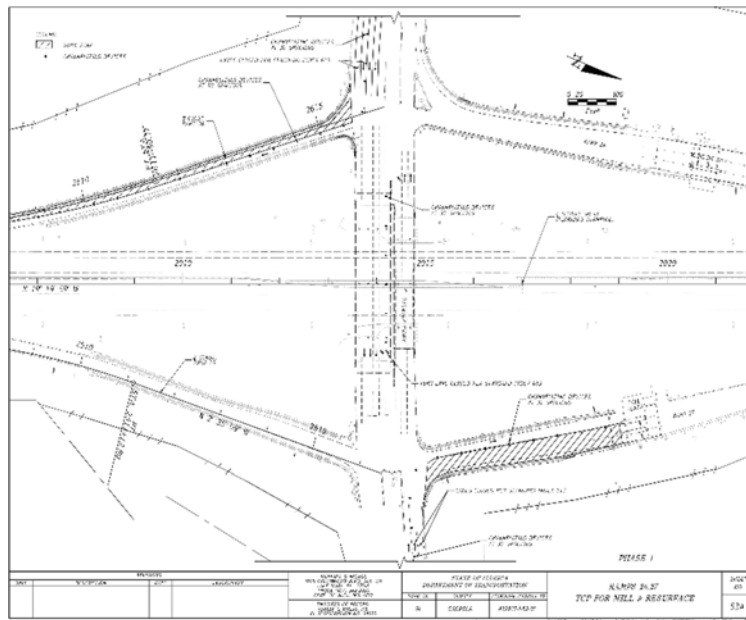
7) MOT details at Osceola PKWY for ramp milling & resurfacing

Contract did not provide MOT details for lane closures on Osceola Pkwy, which were required for the ramp milling & resurfacing. A dedicated right turn lane & one through lane on Osceola Pkwy required closure to prevent turning trucks from cutting across the construction zone.

Also, one of two left turn lanes, from Osceola Pkwy onto the Turnpike entrance ramp, required closure during paving operation. MOT details for this were not provided, and had to be produced during construction.

Lastly, lane closure coordination was not performed Osceola County, during design.

The EOR provided an MOT detail sheet, and the Contractor had to obtain a lane closure permit from the county (Osceola). Auto-turn analysis was required for MOT layout.

Contract plans should include MOT for paving near ramps terminations, and MOT coordination with adjacent counties should occur during design. Special attention is needed for multi-turn lanes & truck turning radii.

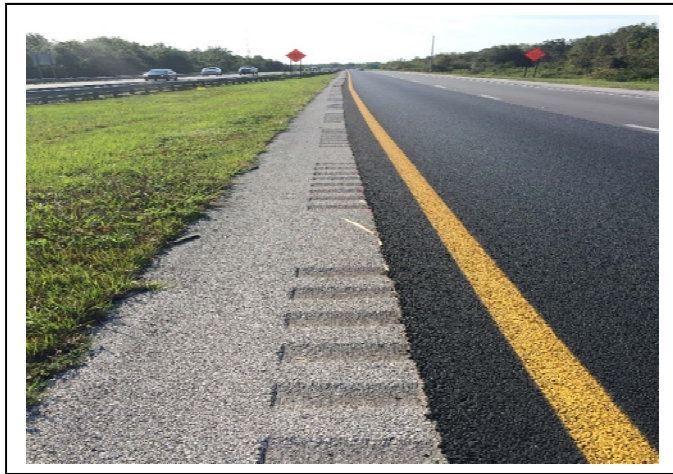
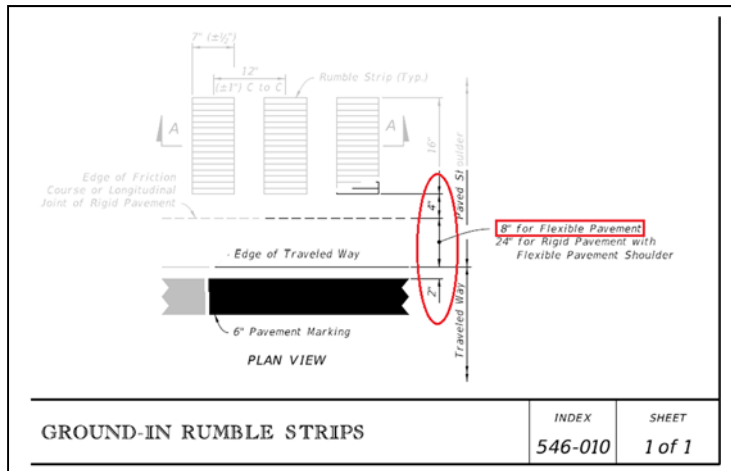
8) Existing rumble strips not in line with new edge of pavement

The alignment of the existing rumble strips varied, creating an inconsistent distance between edge of friction and rumble strips. Because the shoulders were not resurfaced in this project, the new edge of friction inherited this inconsistency. This made compliance with Standard Plan 546-010 (Index 518 impossible at some locations.

The friction course layout had to be adapted to the existing rumble strips' inconsistencies. A future widening project, planned for 2021 at this location, will remove these inconsistent rumble strips.

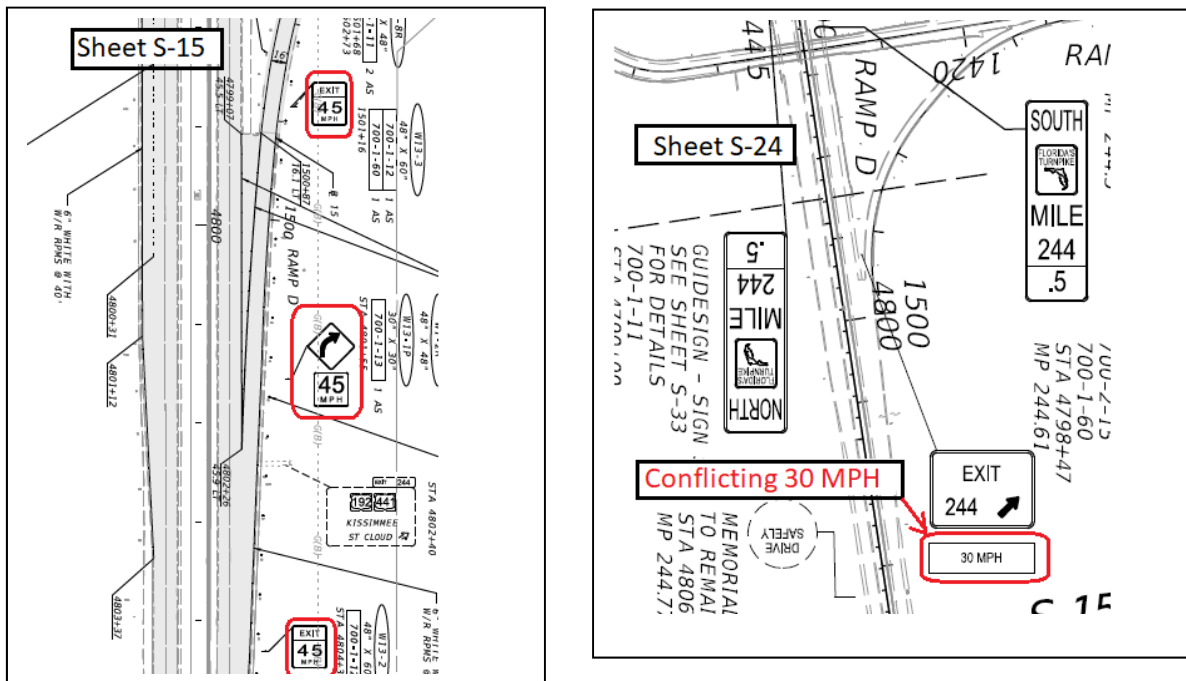
9) Conflicting Speed Limit Signage (Ramp 15)

Conflicting speed signage was depicted at the same ramp location. One of the S&PM plan sheets called for installation of 45 mph advisory speed limit signs at three locations, while a different S&PM sheet called for '30 mph' on supplemental speed limit signage.

After review with Turnpike Traffic Operations & Production, the EOR revised the plan sheet to change the speed limit for two advisory signs to 30 mph, to coincide with the supplemental sign. The advisory sign closer to the mainline was also changed, from 45 mph to 40 mph.

If possible, all signs for a given location should be on the same plan sheet, rather than on multiple as shown above. Thoroughly review all sign sheets to ensure that there's no conflicting signs.

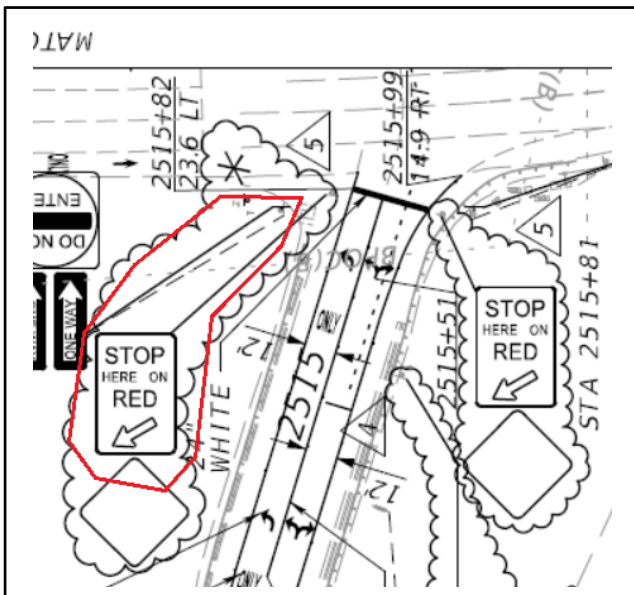
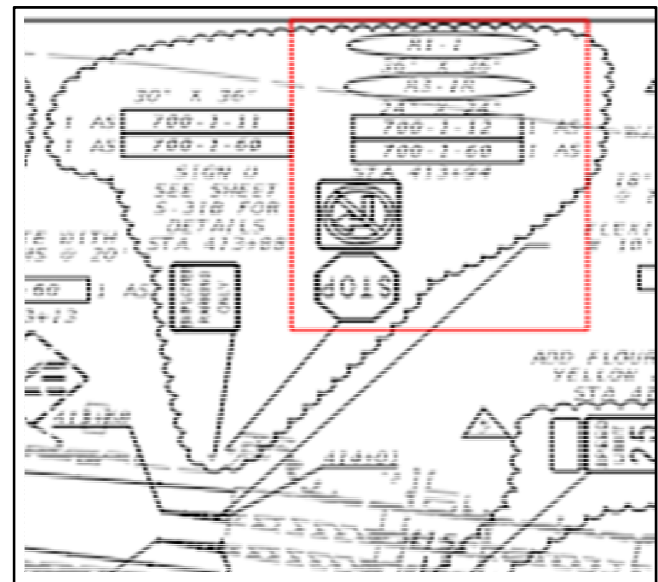
## 10) Sign arrows with wrong directions

- “STOP HERE ON RED” sign; The arrow pointed wrong direction, toward shoulder instead of stop bar (NB Exit to Osceola Pkwy).
- Arrow under “STOP” sign; Arrow pointed in wrong direction (SB Exit to Osceola Pkwy)

The CEI & Contractor coordinated the correct arrow's installation.

Review plans & field conditions for correct direction of arrows.

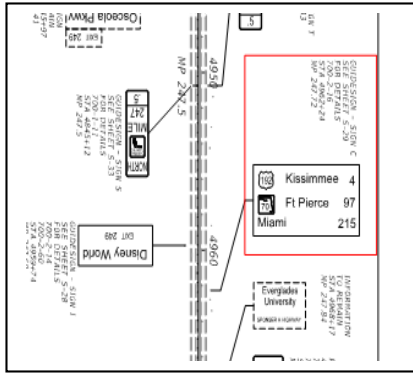
## 11) Multi-post sign conflicting with FGT line

The S&PM plans called for installation of a new multi-post sign panel. The designed offset placed a sign post within 5 feet of an FGT line, which was not shown in the plans. The sign couldn't be shifted laterally, as it would conflict with either the clear zone or vegetation. It also couldn't be shifted longitudinally, since the FGT line ran continuously in this area.

After discussing with Production and EOR, the new multi-post sign remained the same location as existing sign at MP 248.01.

Cross reference existing utilities when designing signage plans, with special consideration for FGT.

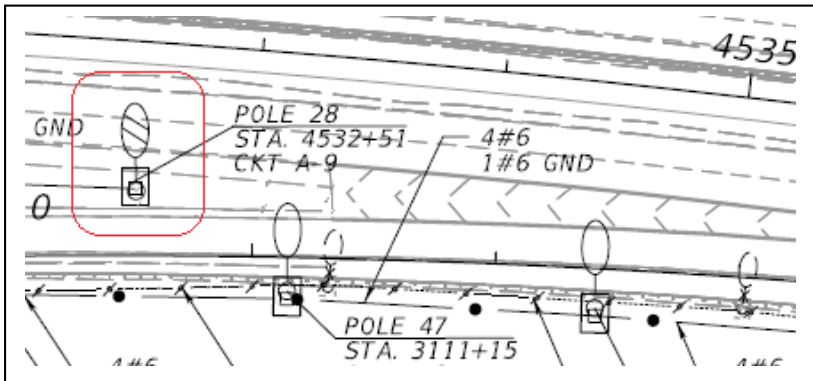
**12) Light pole location in the ramp clear zone**

The proposed location of a new light pole was in the ramp clear zone.

After performing a photometric analysis, the EOR recommended deleting this light altogether (per RFI # 5).

Review lighting plans for clear zone requirements.

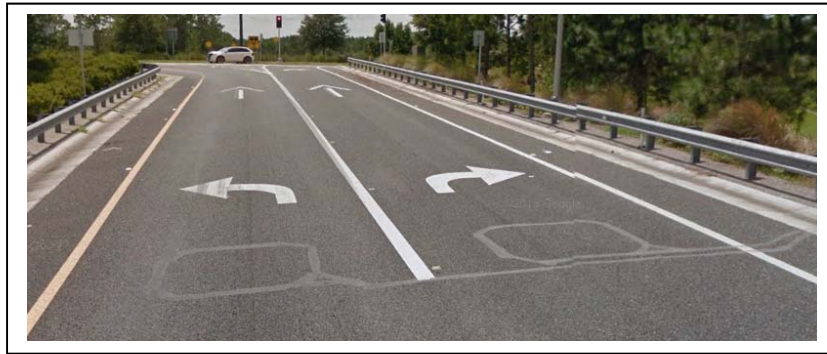
13) Signal Loops not replaced in plans

The advance loops were removed during the paving operation, but the plans did not call for their replacement. This caused the traffic to stop on Kissimmee Park Rd. every cycle. These loops are used for activating the signal when traffic queue's too far down the ramp.

Replacement loops were installed back on the ramp, after the county noticed the signals were not functioning properly. This was paid for by work order.

Evaluate & account for existing traffic loops during design.

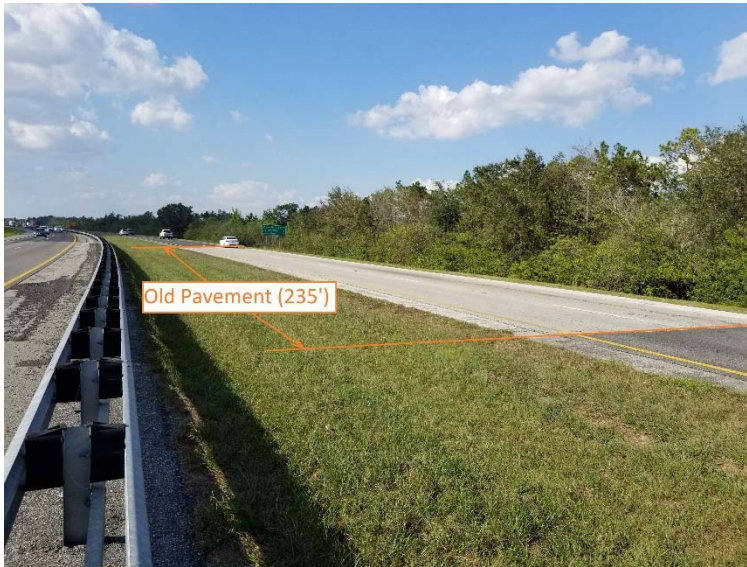
## 15) Limits of milling & resurfacing

235' of distressed pavement was omitted from the southern project limit. This small segment was intended to be addressed in a future widening project, within a year of this project's completion. That future project has since been postponed.

M&R completely to adjacent joints between old & new pavement.
