EXTINGUISH THE TORCH MEETING

Project: Reconstruct Turnpike Mainline Orange County, MP 269.4-273.3

LESSONS LEARNED

SUMMARY REPORT

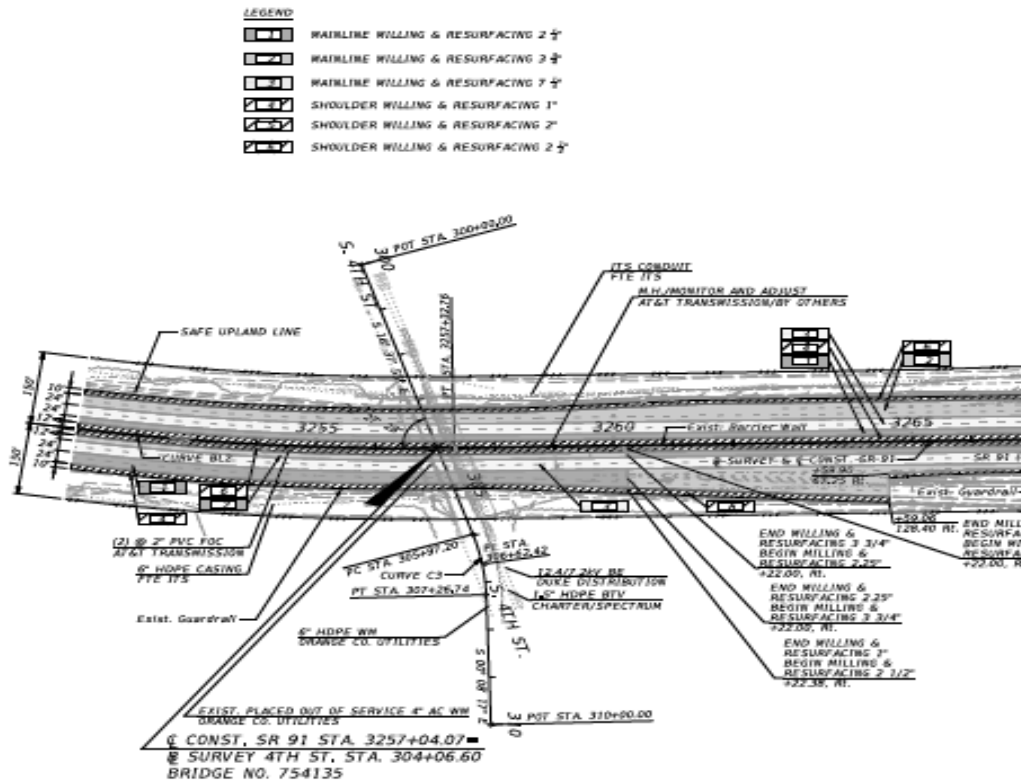
1) Plan Scale and Legends – Indicating Pavement Construction:

ISSUE SUMMARY: There is substantial information on each page, so when the scale is small, the Plan Views are more difficult to read. The legends are very helpful, but with just the variance of shading it is difficult to determine the limit of each area. The Contractor made various errors in milling and placement which had to be corrected at their cost.

RESOLUTION: The CEI reviewed areas to determine if placement was incorrect due to the Plans or the Contractor’s misreading of the Plans and requested the Contractor to make corrections.

RECOMMENDATION: Recommend providing a more definitive set of Plans for resurfacing/ reconstruction of the roadway by providing more distinctive legends and delineation of milling and resurfacing areas, especially with the number of varying depths of resurfacing. The Contractor will be more likely to mill and resurface without having to go back and make corrections.

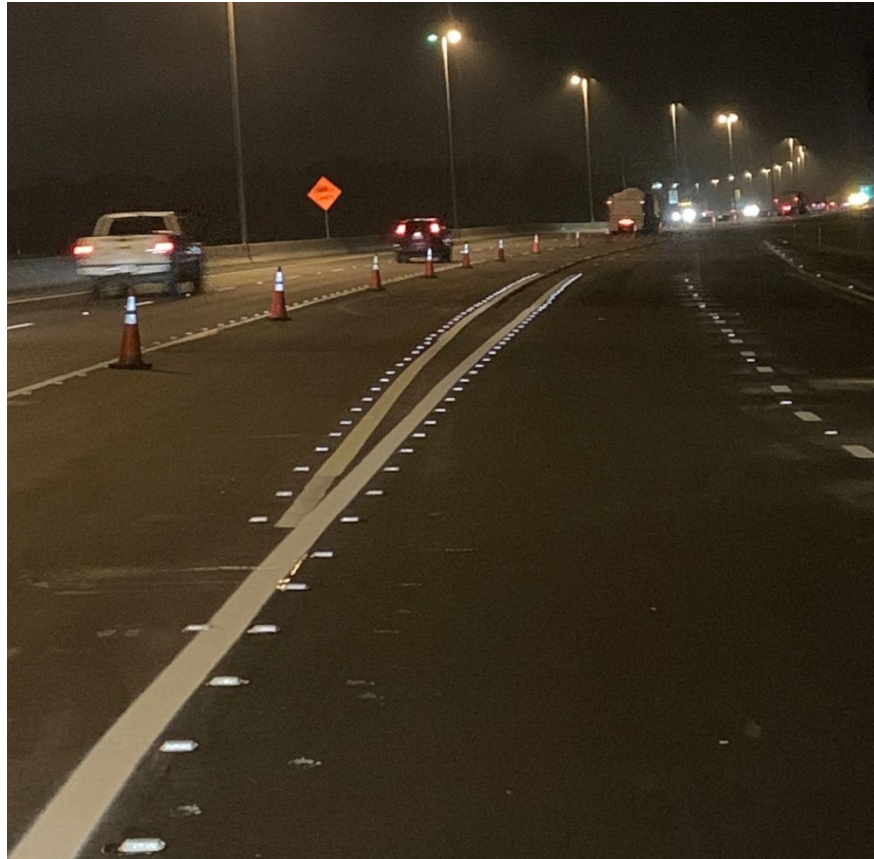
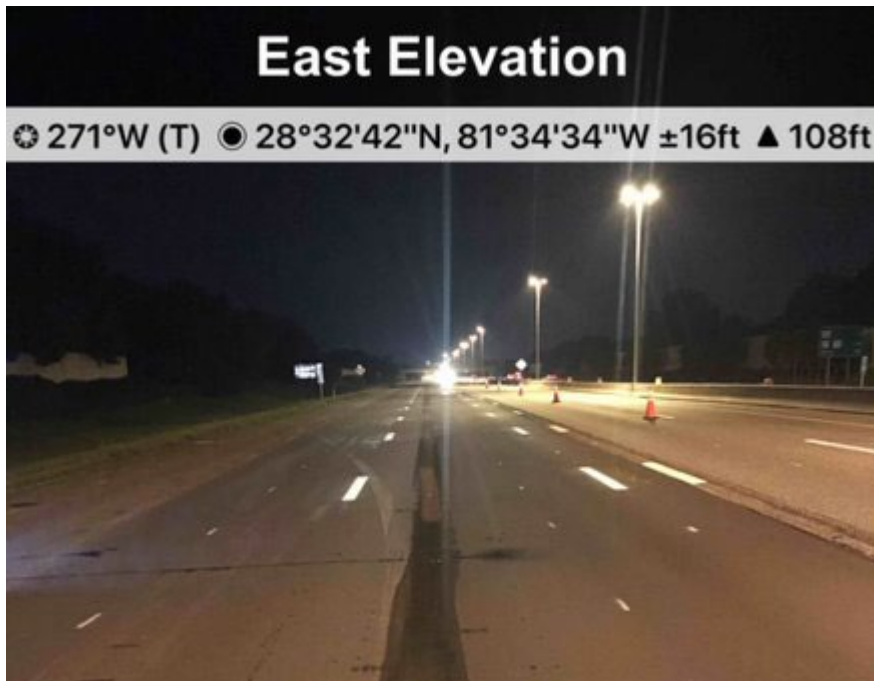
2) Drop-off Mitigation – Driver Expectation:

ISSUE SUMMARY: The roadway on this project consisted of four lanes in each direction. Without shifting traffic, resurfacing the second lane would have placed workers directly next to the third lane, requiring three lanes to be closed. Due to heavy traffic, a triple-lane closure would have significantly shortened the available time to work. Therefore, at certain points in the project, the original TCP required the lanes to be shifted onto the shoulder to allow the contractor to resurface the second lane, maintain two open lanes, and provide workers with a safe distance between the work and the open lanes of traffic. Unfortunately, the resurfacing of this project required a drop-off between resurfaced lanes and the lanes that had not yet been resurfaced. Prior to shifting traffic, the drop-off was at the lane line; however, once the traffic shift was installed, the drop-off was between the vehicles tires, requiring the drivers to drive with one side of the vehicle at a different elevation than the other side of the vehicle. Although no accidents were attributed to this condition, complaints came in from various travelers on the roadway that the ride was uncomfortable and the condition was perceived to be unsafe.

RESOLUTION: Midway through the project, the traffic shift was changed so the drop-off remained at the lane lines. In some areas, this required a triple-lane closure to perform the resurfacing. In other areas, a triple-lane closure was impractical. In those areas, to allow two lanes to remain open while the middle lane was being resurfaced (as was the goal of the original TCP), additional striping was placed so the lanes on either side of the drop-off were at least 4' apart, creating a buffer between the lanes. When the lane on one side of the drop-off was closed for resurfacing, the lane on the other side of the drop-off could be left open, affording workers at least a 4' buffer from the active traffic. During the day when all the lanes were open, the buffer formed a "no drive" area, which could be crossed for lane changes but better assured drivers that they would not have to straddle the drop-off. *Note: This was implemented as a field change.*

RECOMMENDATION: During design, provide traffic shifts, including the use of buffer zones if needed, to assure the drop-offs are contained at the lane lines and provide for smooth transitions when having to travel across the areas with the drop-offs to the next area where work has not been performed.

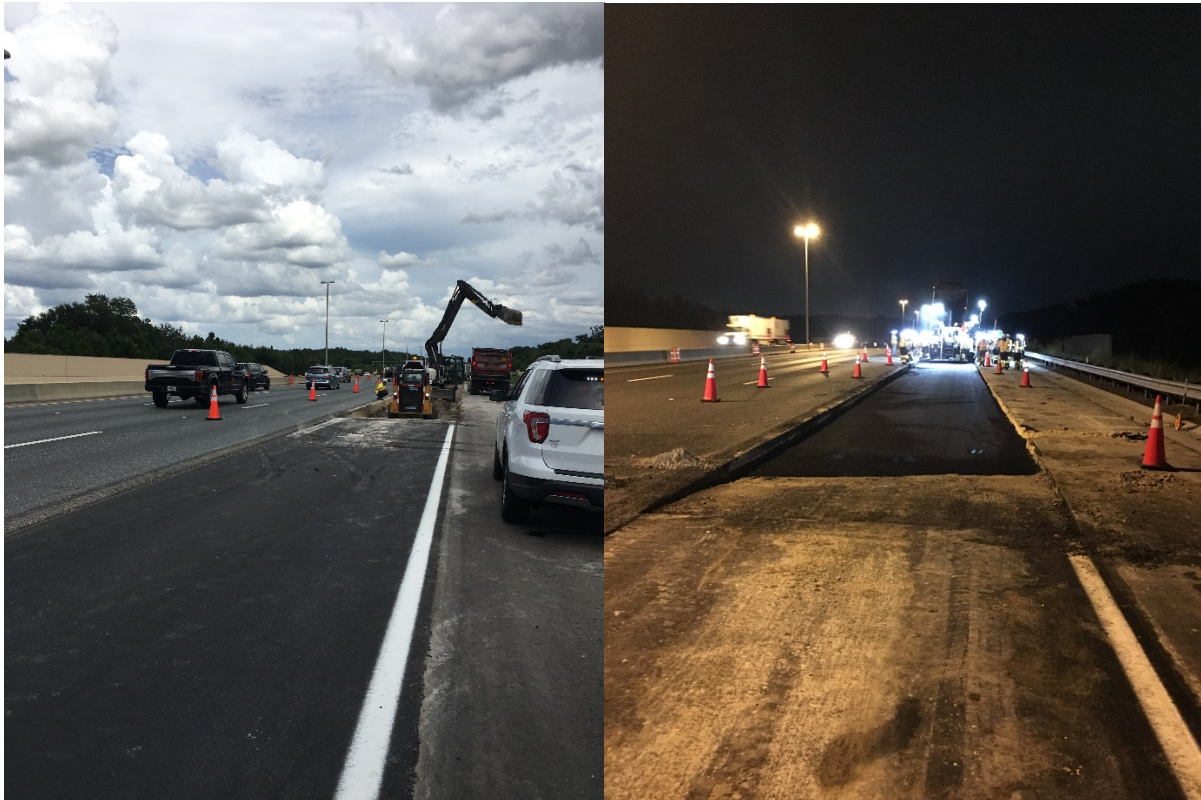
3) Base Failures

ISSUE SUMMARY: Within 24 to 48 hours after completing areas of deep milling into the base, base failures were discovered at three (3) locations.

RESOLUTION: Repaired each location by removing material between 24" and 36" deep, depending on the depth to firm and unyielding material, for the lane width. Type D2 geotextile fabric was then placed followed by 12" to 24" of #57 stone. Finally, 12" of asphalt was placed over the stone.

RECOMMENDATION: Add into contracts, where deep milling occurs, a means to pay for base repairs; excavation, geotextile fabric, #57 stone (24"), etc. Having items in the contract to account for these events would greatly reduce the cost of a repair based on time and materials.

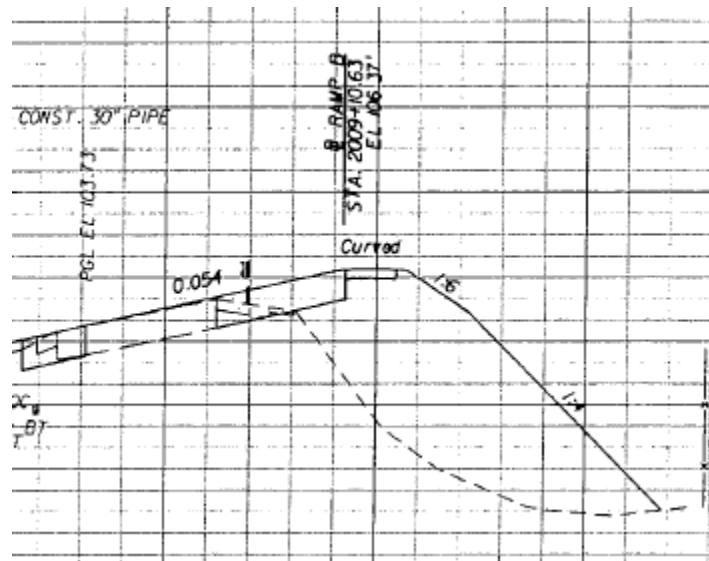
5) Identification of cross-slope changes in the shoulder

ISSUE SUMMARY: After resurfacing of the shoulder, water was being retained within the shoulder area, which was not an existing condition. When temporary pavement is being placed to shift traffic on to the shoulder, the existing shoulder slope can get lost especially for when the shoulder needs to break. The contractor continued paving through this section at the same slope as the shoulder coming into where the break needed to occur.

RESOLUTION: The CEI had procured the Final As-built Plans of the previous construction project and found there was break in the existing shoulder. The as-built plans show this as "Curved". (See below). The contractor was directed to mill and resurface the shoulder to match the existing condition.

RECOMMENDATION: Provide Station and grades for existing shoulder breaks in the Plans.
