Annual Inspection Report

for the Fiscal Year ending June 30, 2023

As General Engineering Consultants to Florida's Turnpike Enterprise (FTE) and in accordance with Section 5.13 of the Turnpike Enterprise Bond Resolution, AtkinsRéalis and HNTB are pleased to submit the annual independent inspection asset condition report of the FTE System for the fiscal year (FY) ending June 30, 2023.

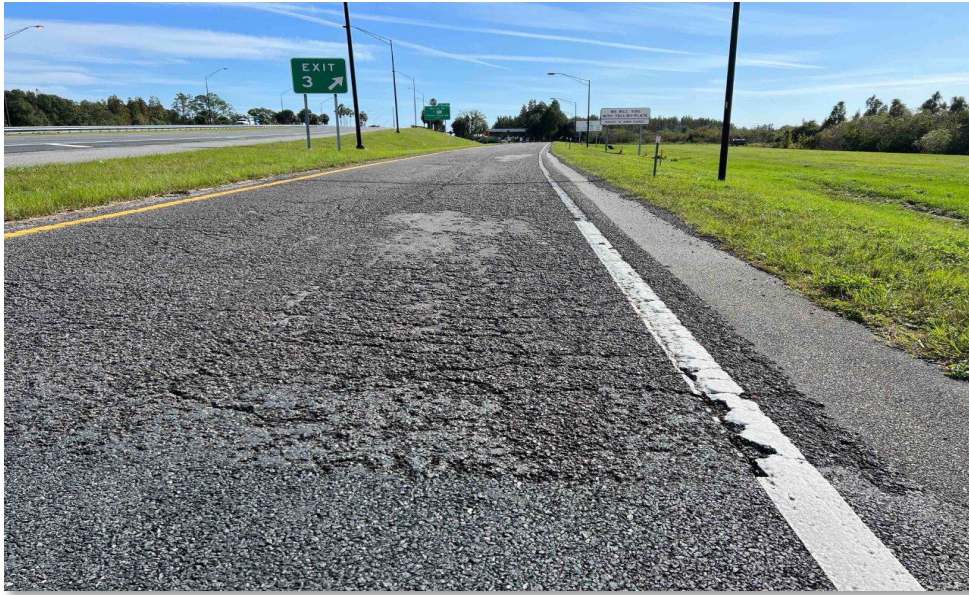
Undesired Pavement Condition - Class III Cracking

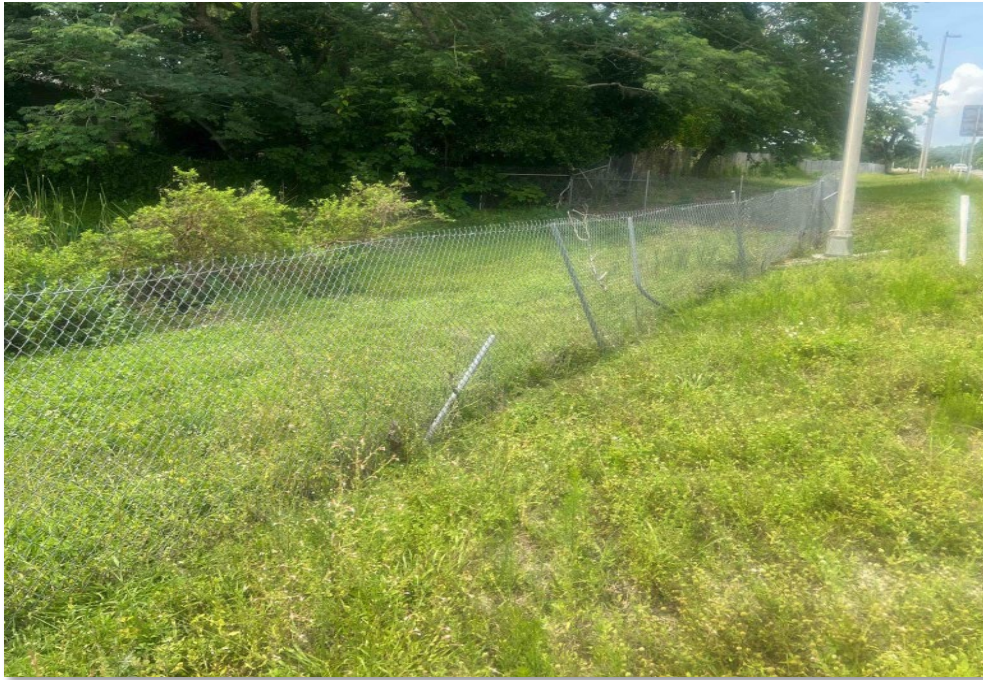
Undesired Fence Condition - Damaged Fence Post

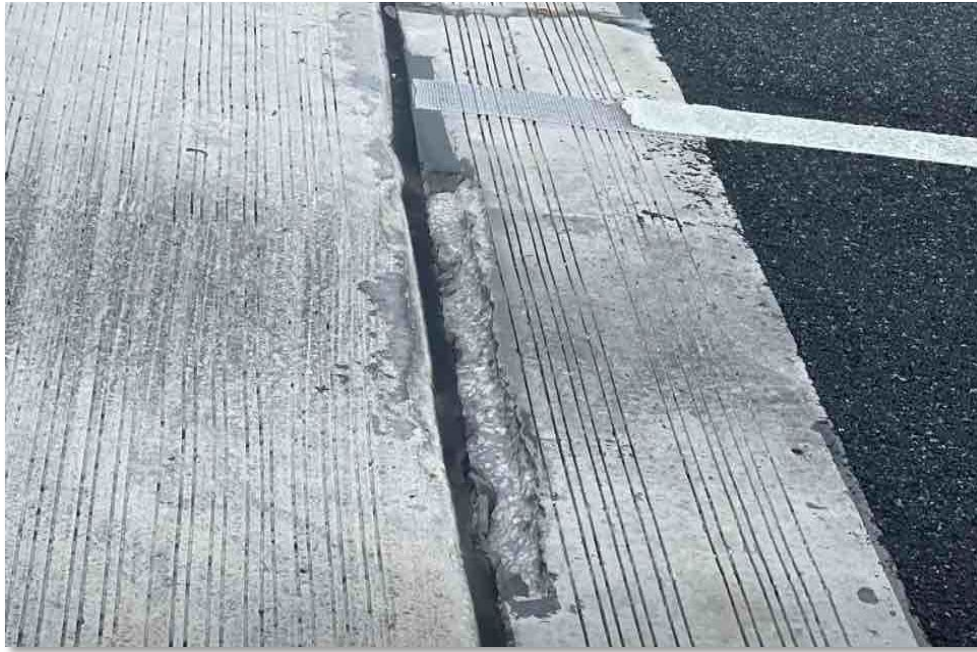
Undesired Joint Condition – Spalled Joint

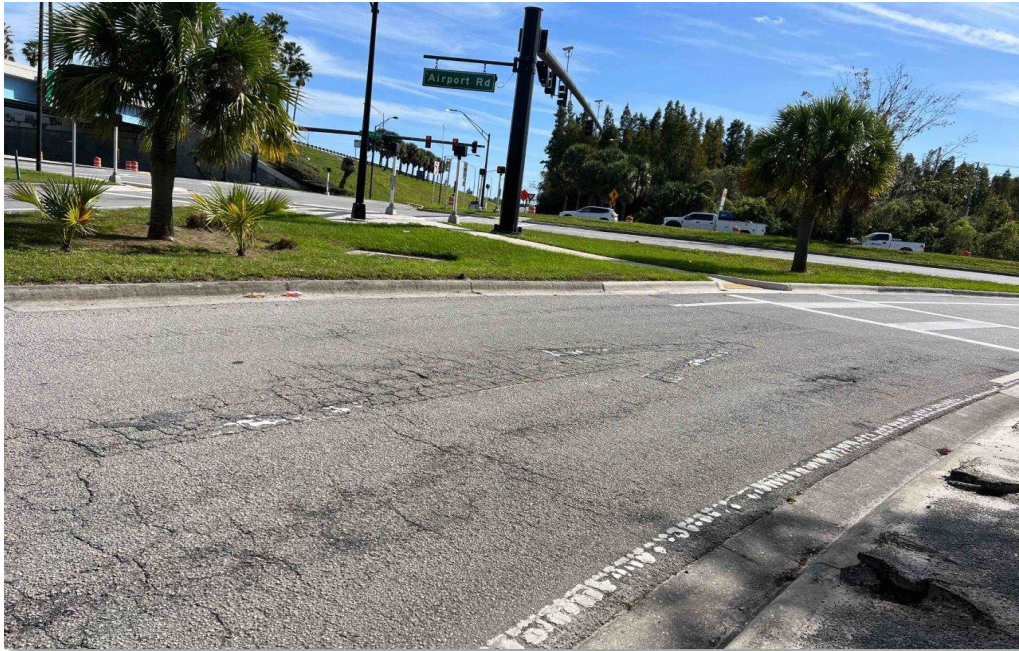
Undesired Pavement Symbol / Cracking

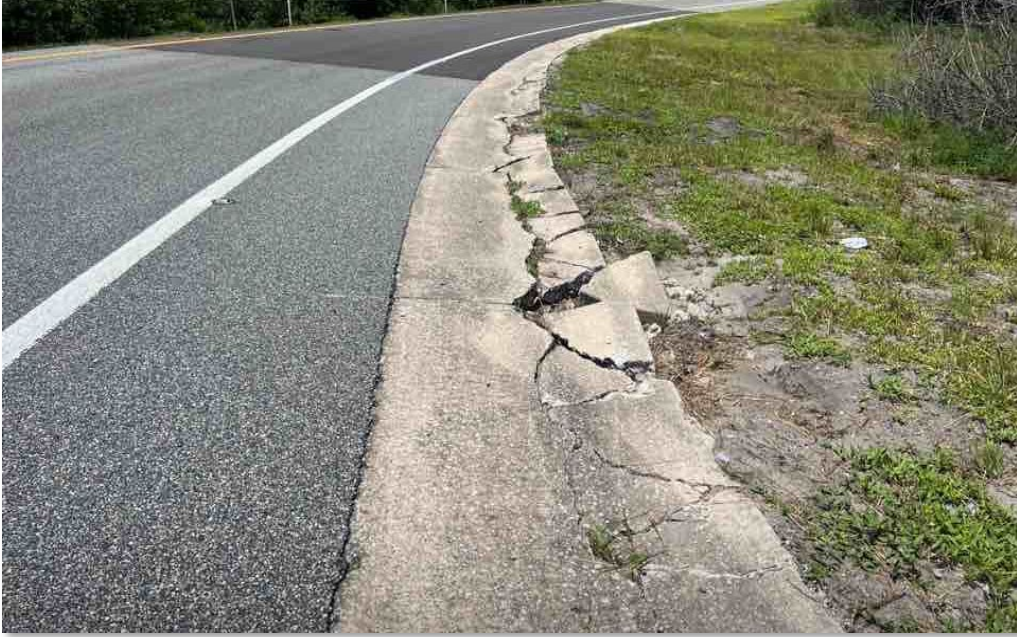
Undesired Shoulder Gutter

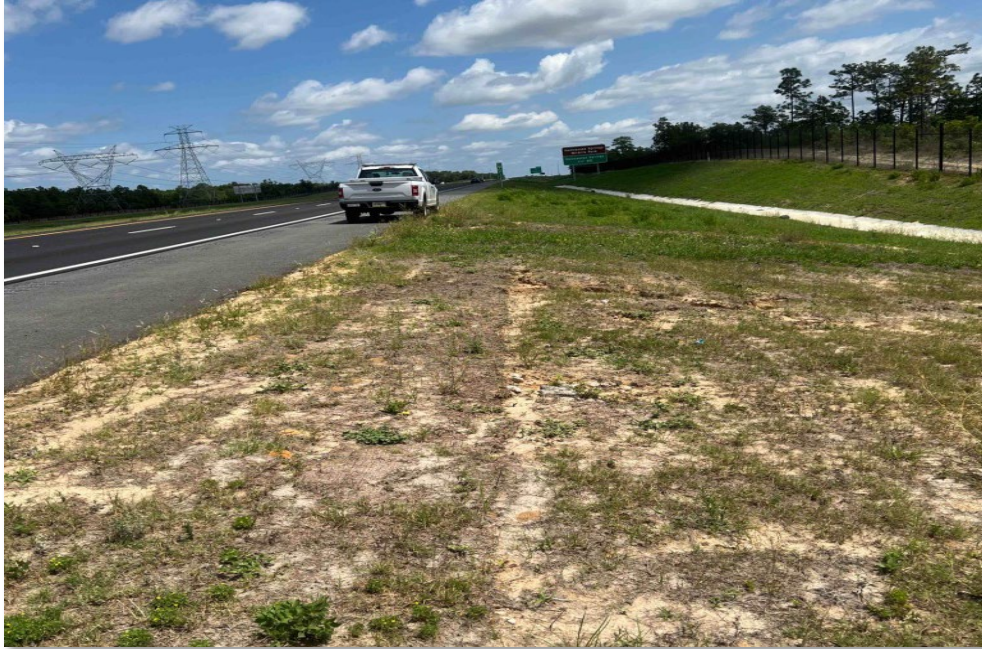
Undesired Turf Condition - Front Slope
