**EXTINGUISH THE TORCH MEETING
SESSION ONE**

FIN: 429331-1-52-01 & 429332-1-52-01
Contract No.: E8M50
Description: SR 91 and I-4 Inter. Improvements Project
Contractor: Middlesex Corporation
Project Acceptance Date: Oct. 21, 2014
County: Orange

SR 91 (Turnpike) and I-4 Interchange Improvements Project Design/Build
FPN's 429331-1-52-01 / 429332-1-52-01
Contract No. E8M50

Lessons Learned

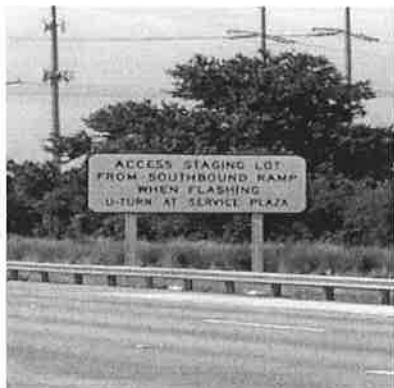
In conjunction with the Turkey Lake truck turn around the RFP added tandem truck features to the I-4/FTE interchange that included new signs with flashing beacons. These signs are intended to direct NB tandem trucks past the I-4/FTE interchange to the Turkey Lake turn around during peak traffic periods. Once the trucks turn around they can exit the Turnpike by using the SB exit ramp and minimize the weaving movement within the interchange. A flashing beacon sign is also installed to prohibit left turns out of the tandem truck lot heading toward I-4.

After construction and prior to implementation of the signs it was decided not to activate the beacons. This decision was made because the SB exit movement inflicted additional tolling onto the trucks and additional analysis was needed prior to implementation.

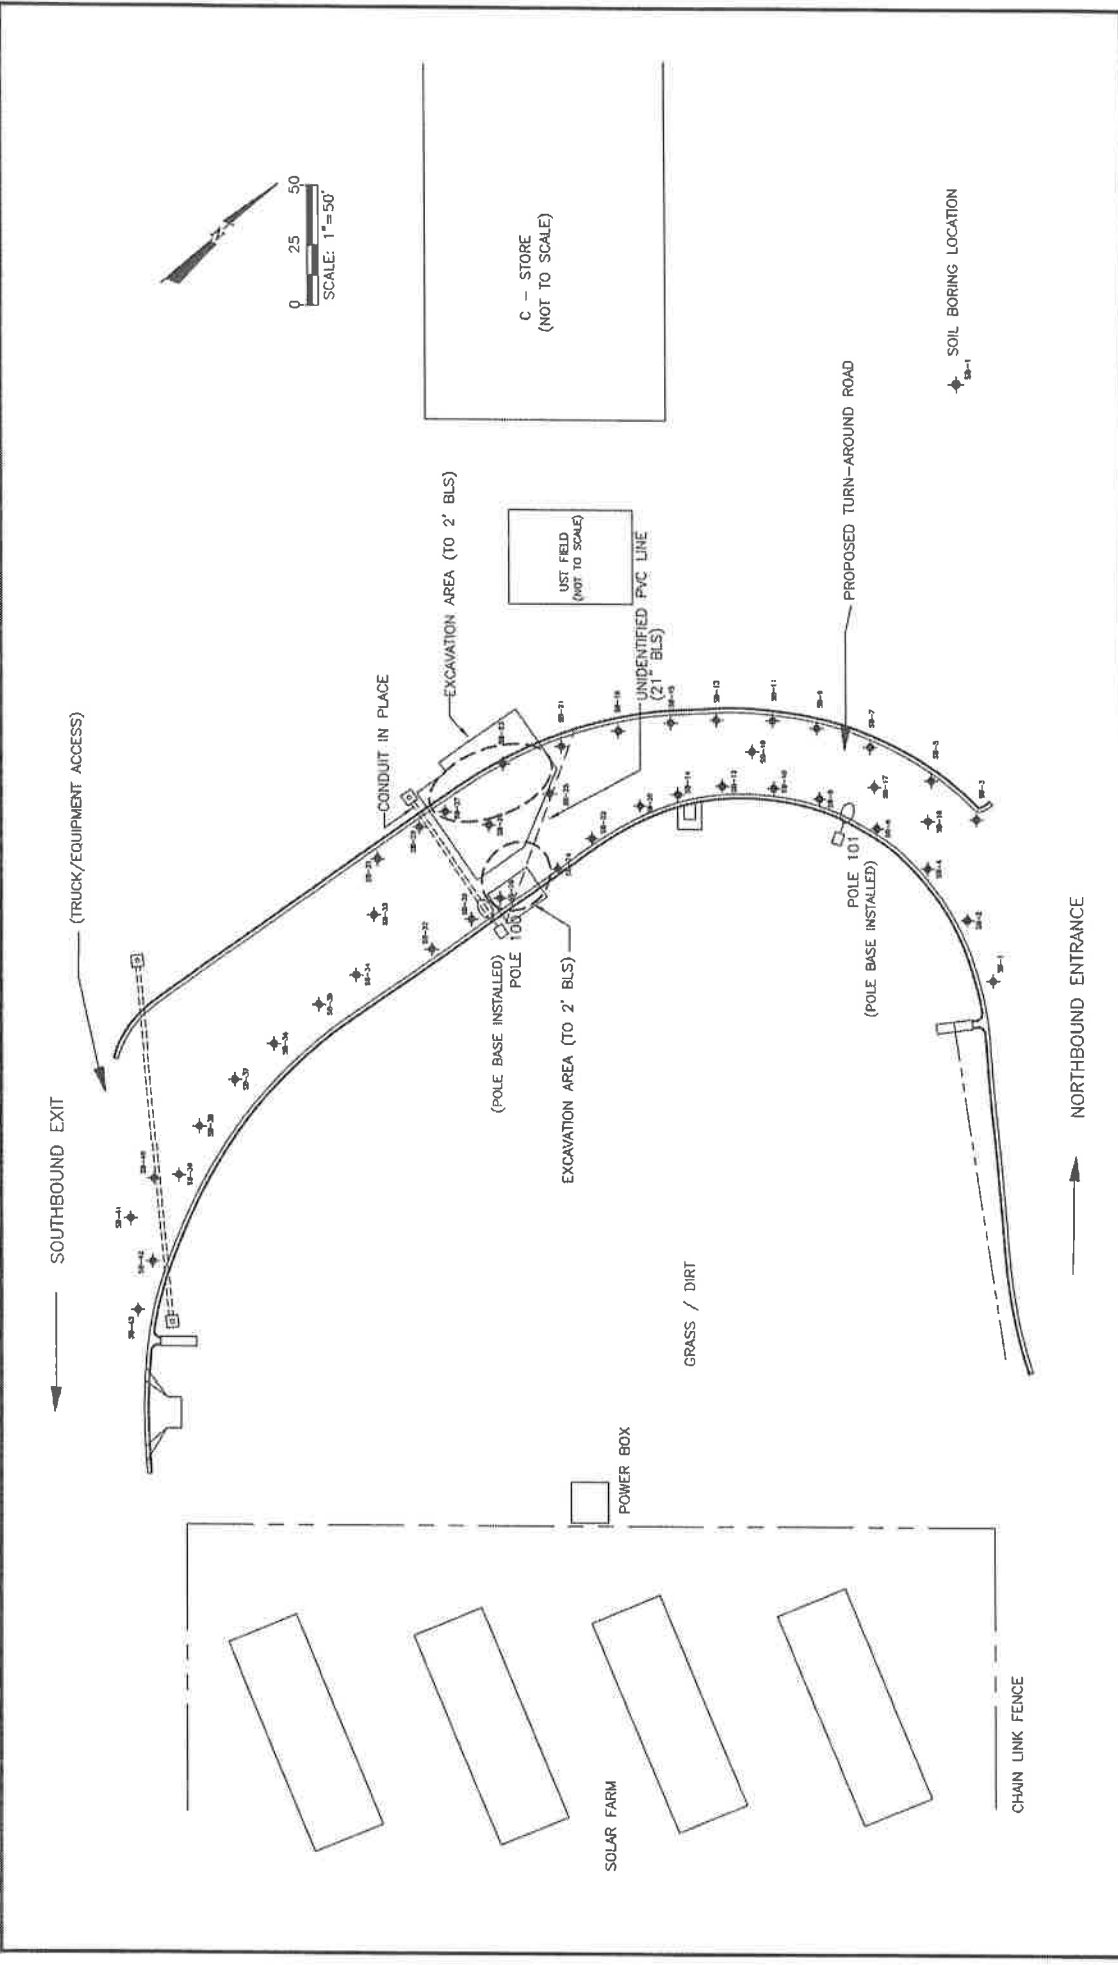
FIGURE 1
 SITE PLAN
 (SOIL EXCAVATION PLAN)

TURKEY LAKE SERVICE PLAZA
 MILE POST 263
 FLORIDA'S TURNPIKE
 01-31-14

During the construction of the Turkey Lake tandem truck turnaround high concentrations of hazardous material vapors were encountered. Construction activities were suspended until a hazard assessment could be performed and solution derived.

CEI called in the Turnpike EMO office to sample and verify the limits of hazardous material. Initially the contractor told us they would only be removing two feet of material so only that strata of material was tested. It was later determined that the two feet of material to be removed was actually two feet below final proposed elevation which was deeper than existing elevation. The environmentalists had to return, test and remove additional material. A miscommunication as to the reference point for the depth of the material to be removed slowed progress on the tandem truck turn around but did not affect the critical path activities.

Additionally a Work Order was executed to provide extra depth limerock base in lieu of the proposed type B stabilization. This change limited the depth of hazardous material removal and eliminated mixing the underlying soils. Cost of the extra work \$11,270.03.

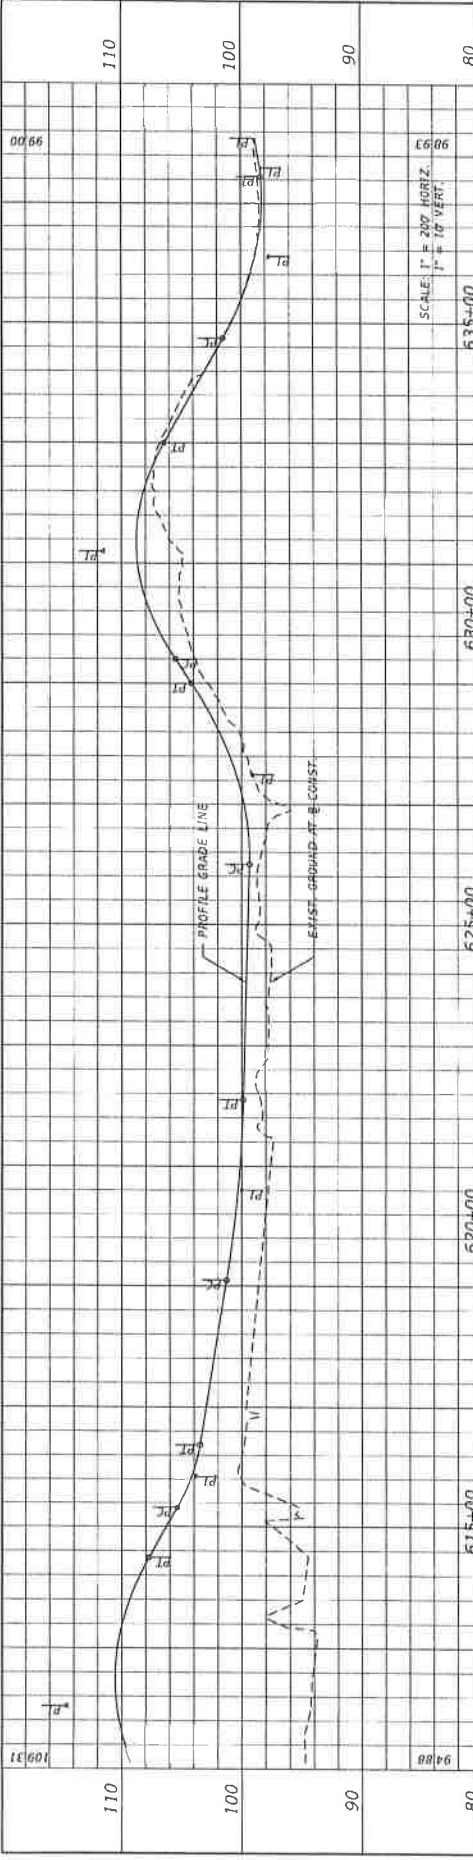
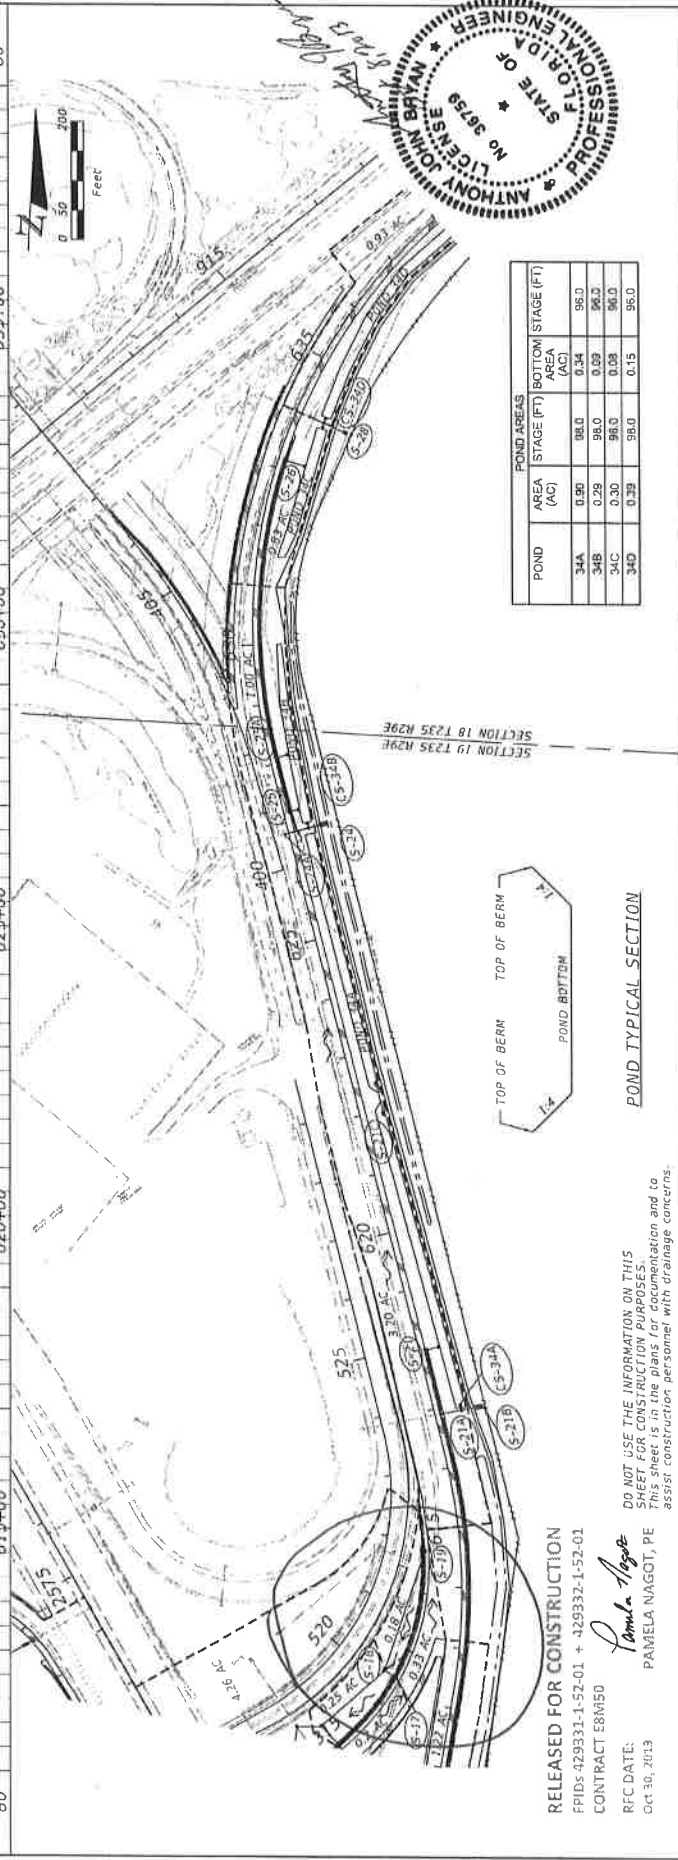
SHEET NO. DM-03

POND	AREA (AC)	STAGE (FT)	BOTTOM AREA (AC)	STAGE (FT)
34A	0.90	98.0	0.34	96.0
34B	0.29	98.0	0.09	96.0
34C	0.30	98.0	0.08	96.0
34D	0.39	98.0	0.15	96.0

POND TYPICAL SECTION

DRAINAGE MAP

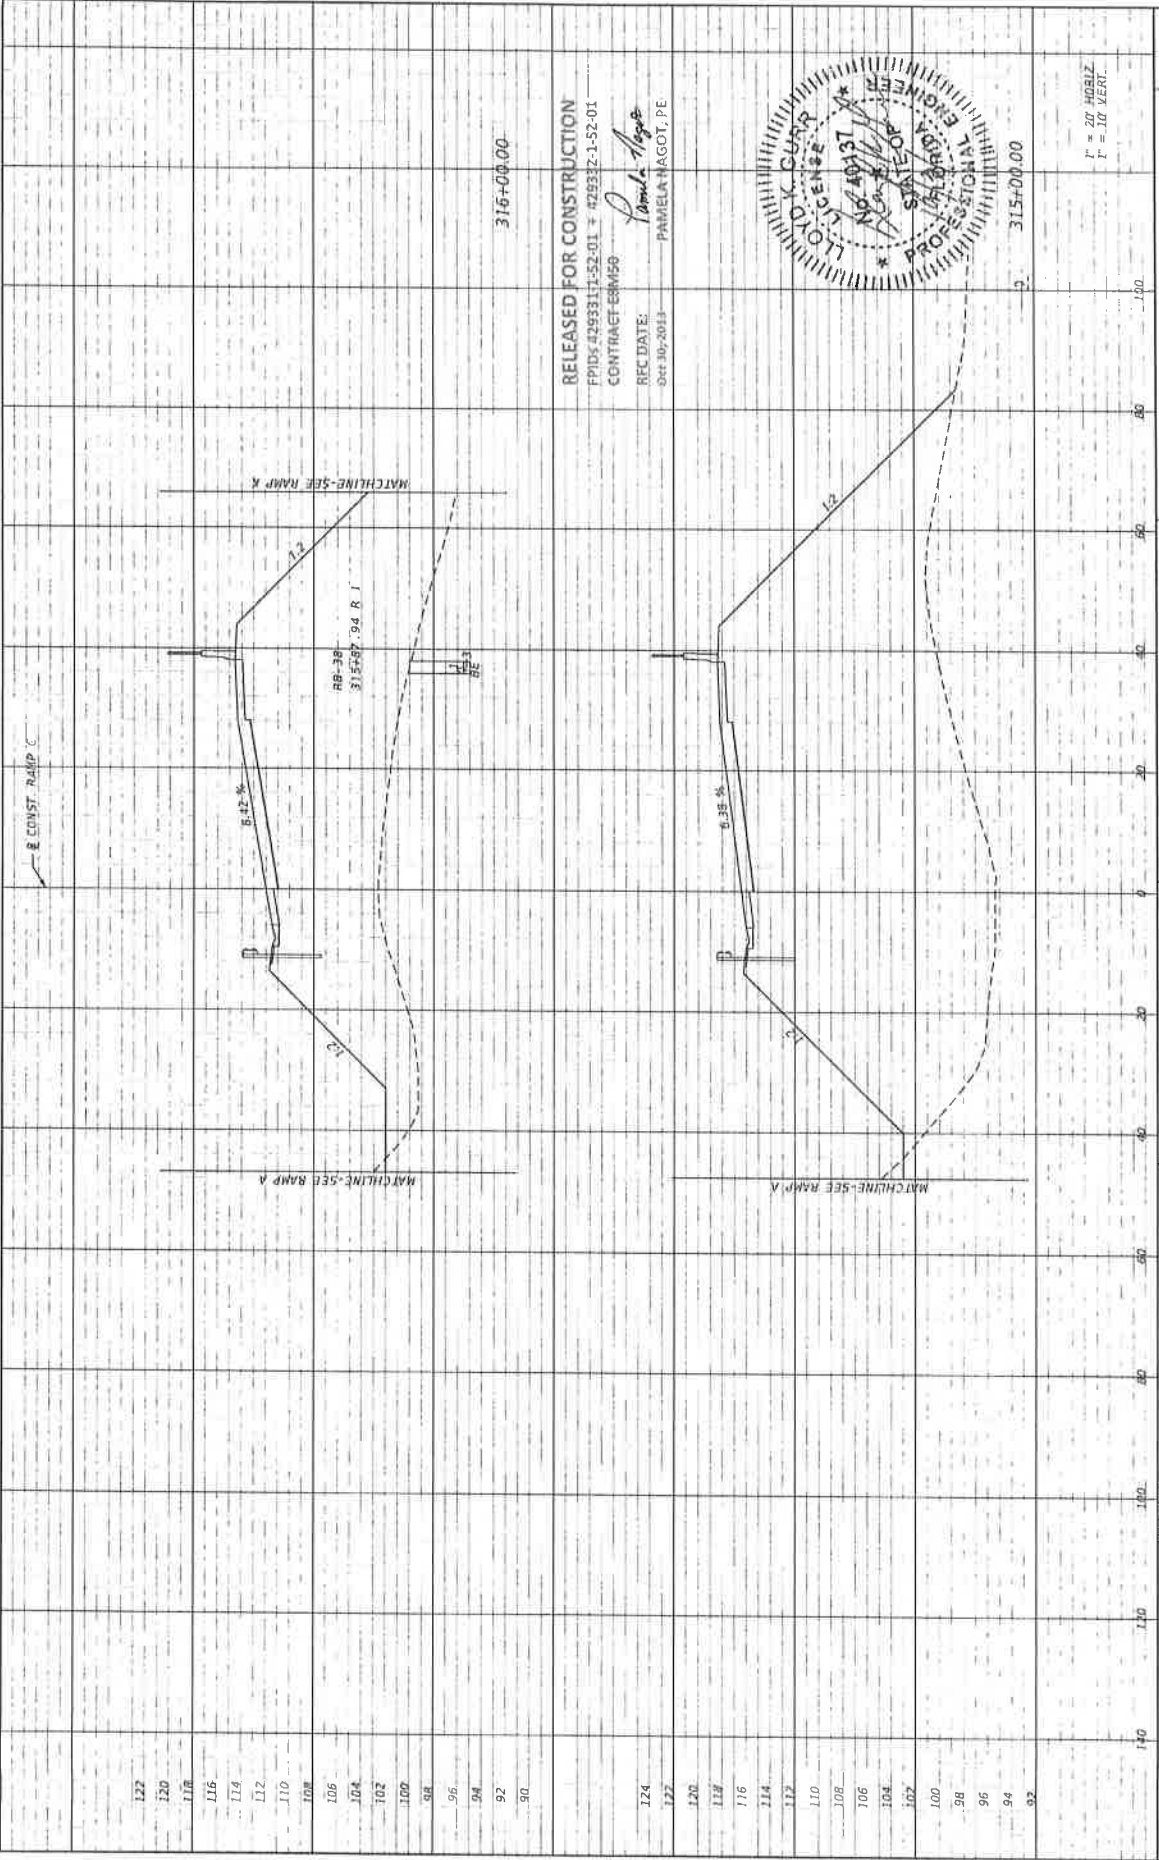
SHEET NO. XS-32

CROSS SECTIONS
 RAMP C

SCALE: 1" = 20' HORIZ
 1" = 10' VERT

The traffic control plan did not address the MOT at the tie to the connector road where ramp C and Ramp K merge. The reported 7 inches of overbuild at the Technical Proposal stage became 16 inches in final design.

It was determined that because of the thickness of the asphalt and drop off conditions both Ramp K and Ramp C traffic NB would have to be detoured to allow enough time to construct the overbuild and place traffic back on safely.

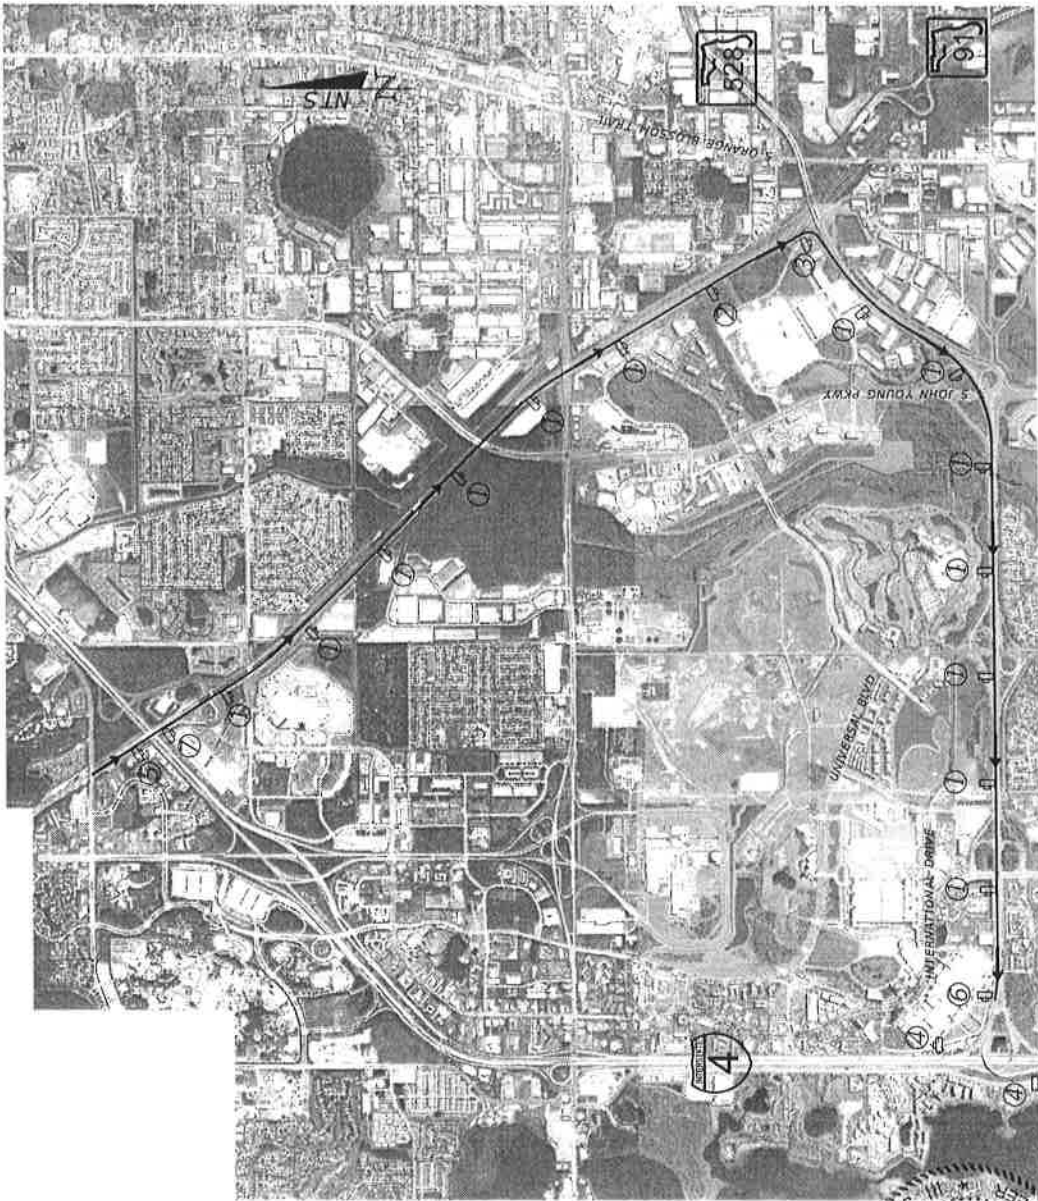
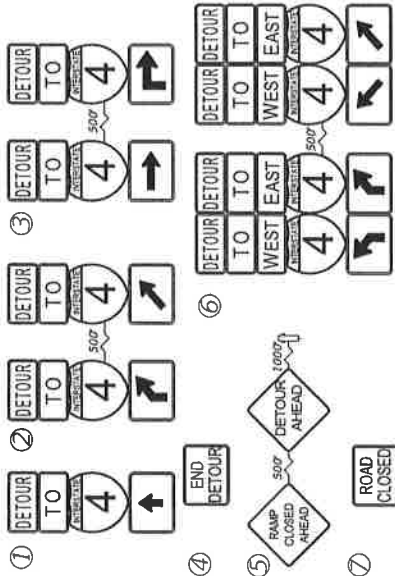
PCMS MESSAGES
2 WEEKS PRIOR TO RAMP CLOSURE

MESSAGE 1
 RAMP TO I-4 CLOSED

MESSAGE 2
 NIGHTLY <DATE> <DATE>

MESSAGE 2
 FOLLOW
 DETOUR

DETOUR LENGTH = 8.25 MI

DETOUR TO BE PRIMARILY USED FOR OVERHEAD SIGN INSTALLATION AND REMOVAL ON CONNECTOR ROADS.
