**LEVEL I
CONTAMINATION SCREENING EVALUATION REPORT
(MAINLINE AND DRAINAGE SITES)**

Project Development and Environment (PD&E) Study to

Widen Western Beltway (SR 429)

from North of I-4/SR 429 Interchange to Seidel Road

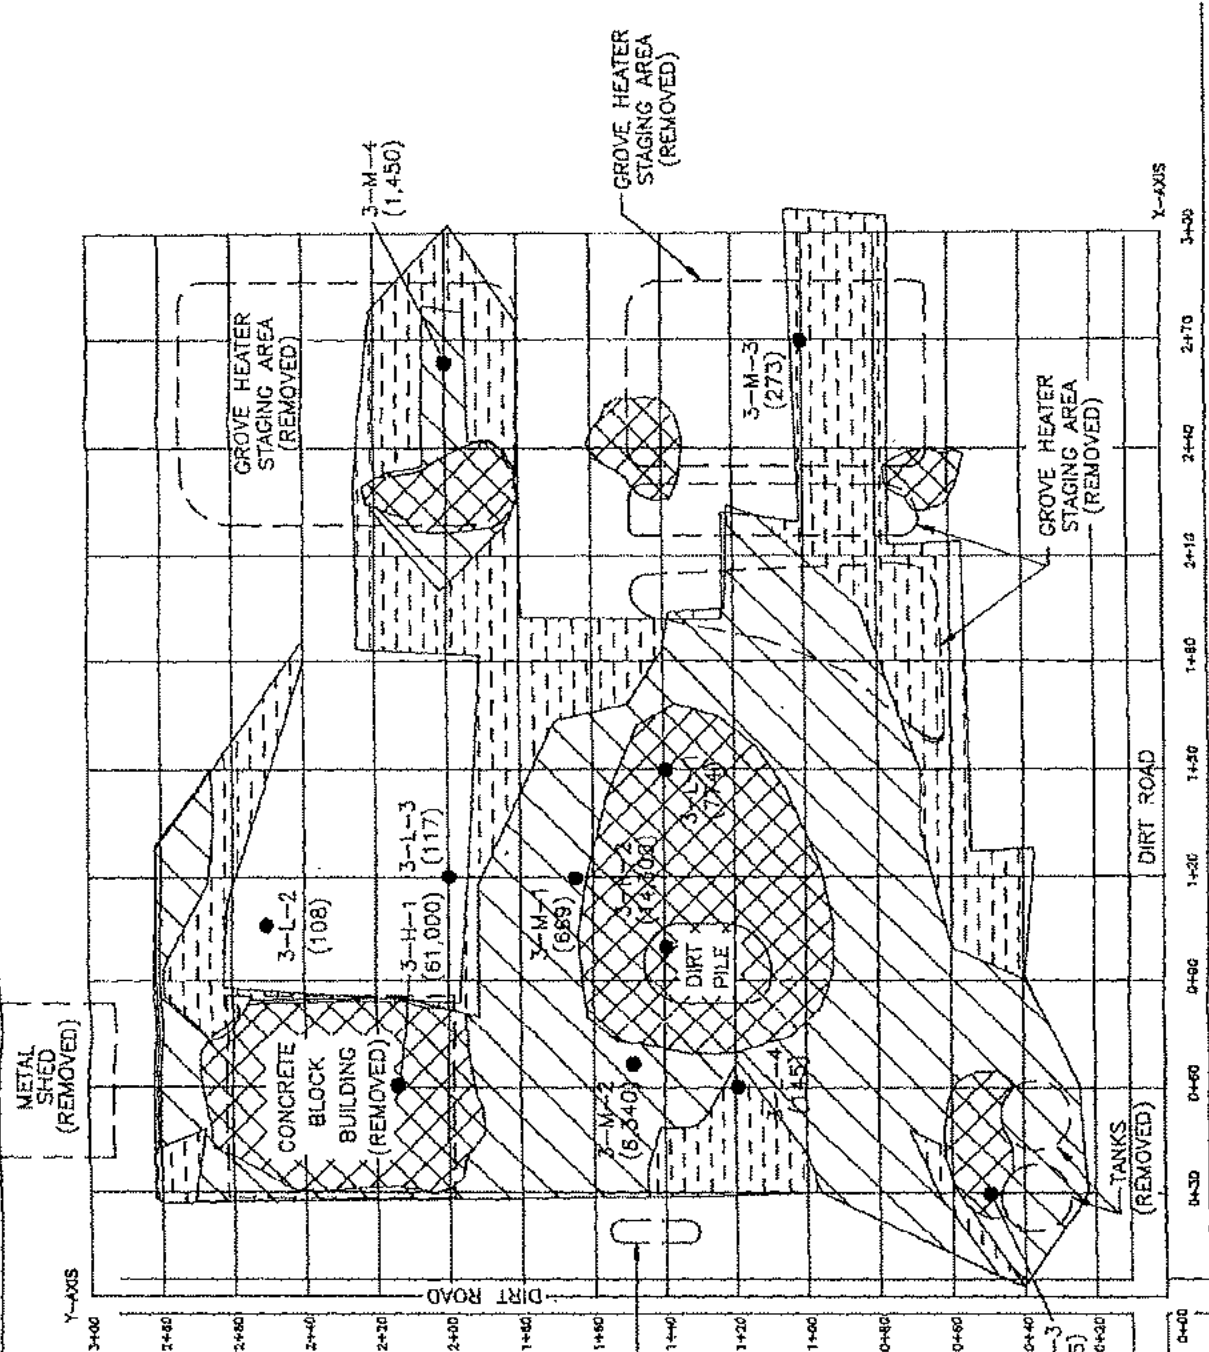
TRPH pre-burn sampling results are also shown on Figure 6-1. As indicated by these results, TRPH concentrations generally confirm trends in contamination levels determined by previous PID readings collected during the initial headspace assessment. Again, although no direct correlation exists between these two analysis methods, the highest values of both analysis methods occurred in the vicinity of petroleum source locations, and lower values occurred near the perimeter of the study area.
